2019 Operational Reliability Assessment of the Longhorn Pipeline System

Final Report

Magellan Pipeline Company

Kiefner and Associates
1608 S. Duff, Suite 400
Ames, IA 50010

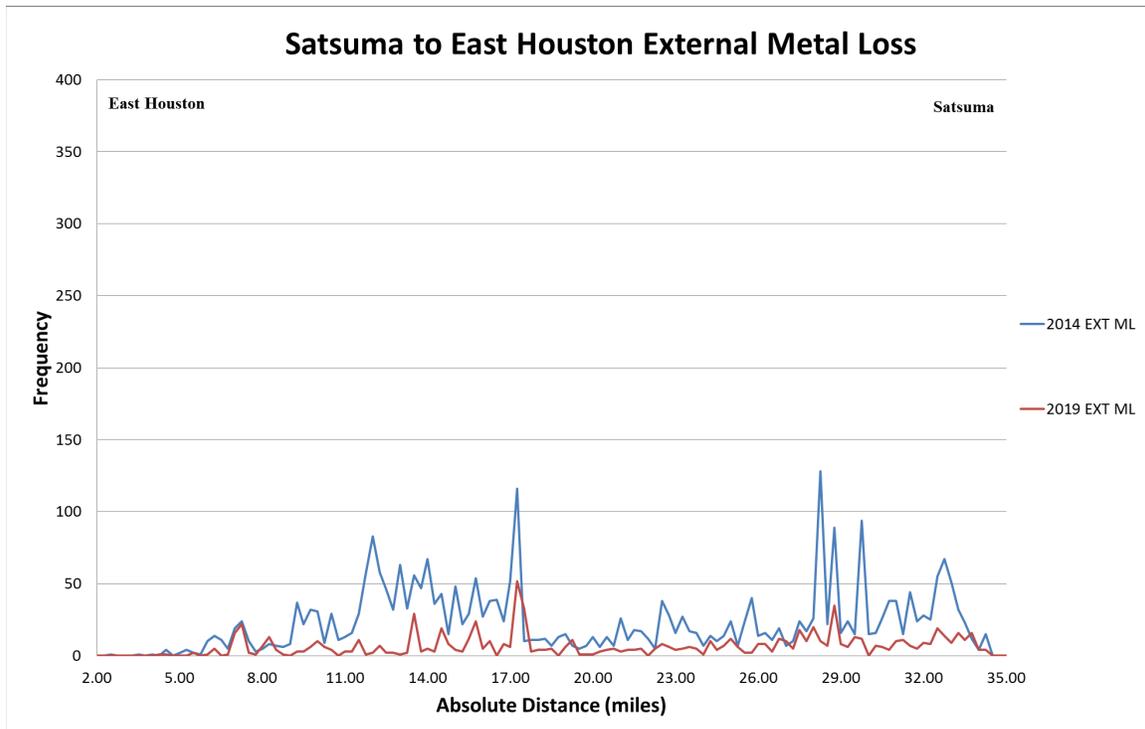
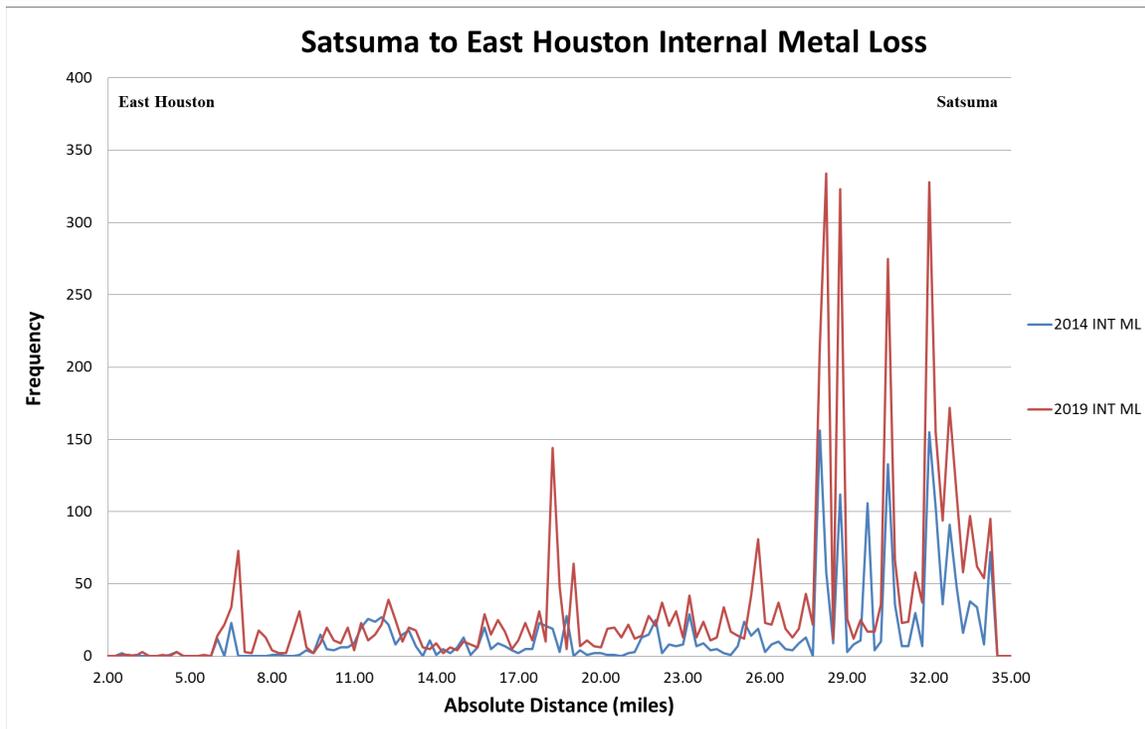
Figure 8. Satsuma to East Houston ML Frequency by Linear Distance along the Pipeline (2014 MFL vs 2019 SMFL)

- Figure 8 and Figure 9 show histograms for Satsuma to East Houston; Figure 8 shows the external and internal ML features broken out separately while Figure 9 shows the external and internal ML features combined. Figure 9 indicates the 2019 ILI assessment is reporting more ML features overall than the 2014 ILI assessment and also indicates that there is a possible difference in how external and internal features were reported between the two assessments. There are 23 external ML features from the 2019 assessment that correlate with internal ML features from 2014 and 745 internal ML features from the 2019 assessment that correlate with external ML features from 2014.

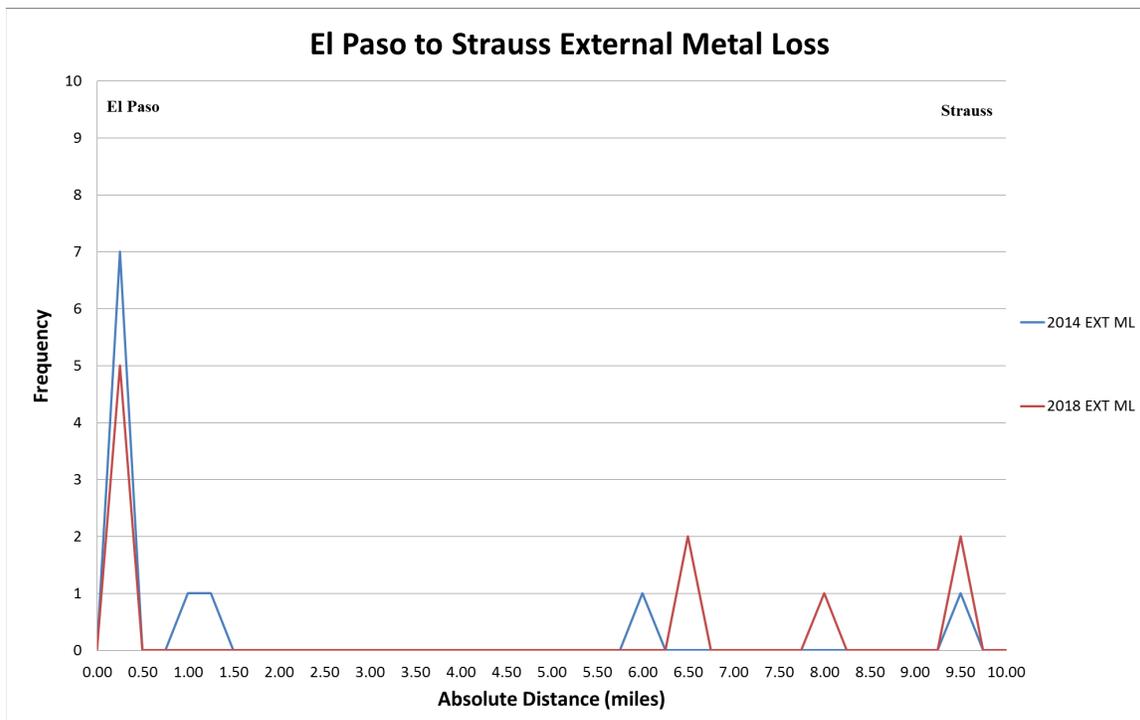
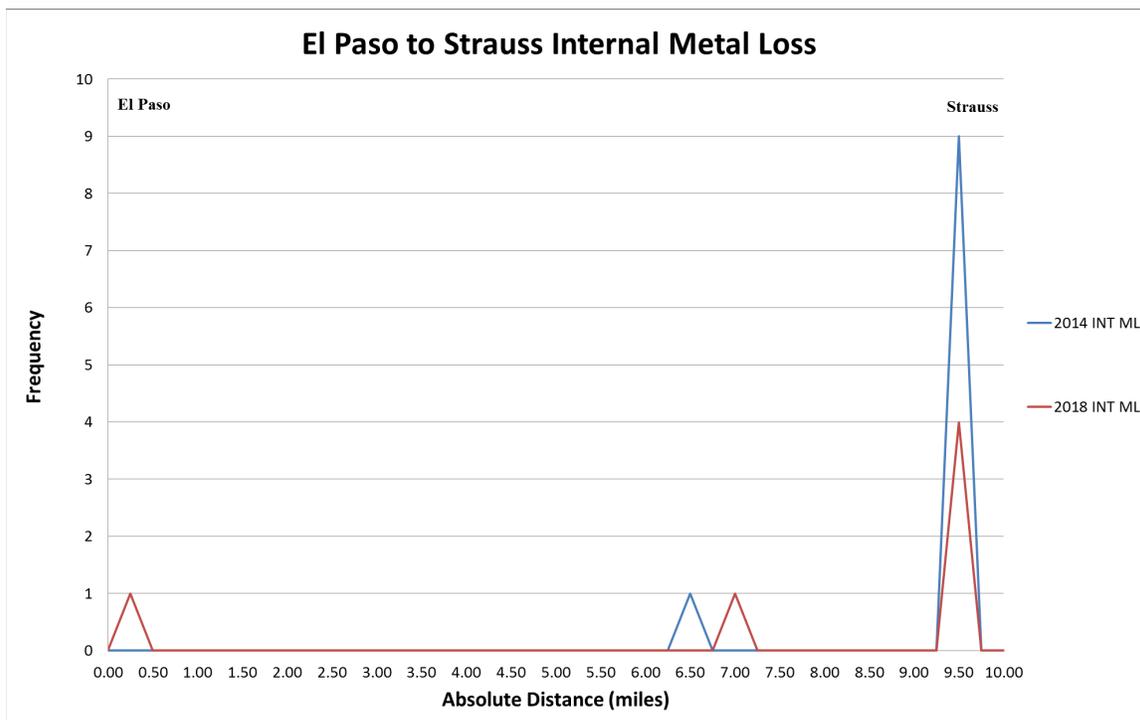
Figure 10. El Paso to Strauss ML Frequency by Linear Distance along the Pipeline (2014 MFL to 2018 MFL)

- Figure 10 shows histograms for El Paso to Strauss. Figure 10 is showing similar ML feature counts between the two ILI assessments. All ML features from both assessments (2014 and 2019) had reported depths $\leq 18\%$ WT. Due to the low level of corrosion and the tool tolerance ($\pm 10\%$ WT) there are a couple of areas where one assessment reported a ML feature, and the other assessment did not report a feature; example between MP 6.0 and 7.0. There is one external ML feature from the 2019 assessment that correlate with an internal ML feature from 2014 and one internal ML feature from the 2019 assessment that correlate with an external ML feature from 2014.

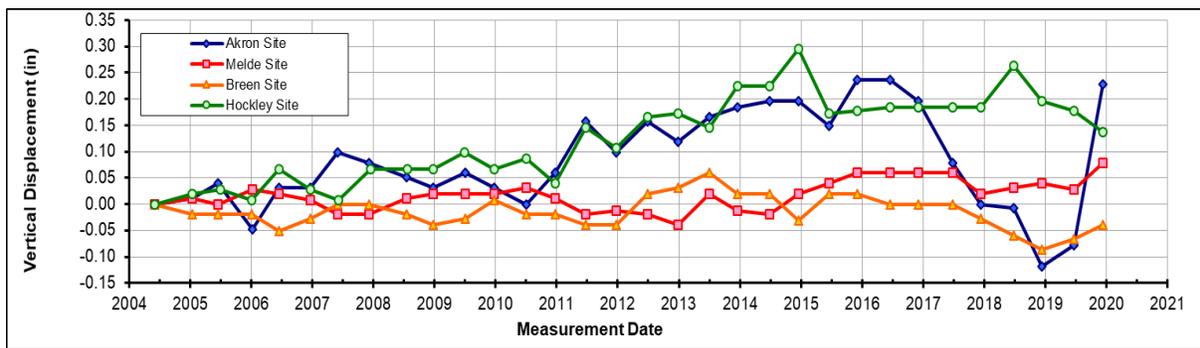
Figure 11. Fault Displacement over the 15.5 Year Monitoring Period at Akron, Melde, Breen, and Hockley Faults

Monitoring stations across the Akron, Melde, Breen, and Hockley faults were installed in March 2004 in accordance with Section 6.2 of the ORAPM. Baseline readings were taken in late May and early June 2004. Thirty-one subsequent displacement readings¹⁵ have been taken at approximately 6-month intervals. A plot of the vertical displacements over time is shown in Figure 11. Magellan performed maintenance activities to relieve stress on the pipeline at the Hockley fault in 2019.

In 2017 and 2018, there was a considerable amount of backward movement in the Akron fault in comparison to the previous 12 years of monitoring. This trend was followed by a rebound in 2019 when the fault approximately got back to its previous displacement prior to 2017. It should be noted that the readings measured in mid-December 2019¹⁶ indicated an atypically large change in displacement between survey events (greater than 0.2 inches). This rate of movement requires close monitoring.

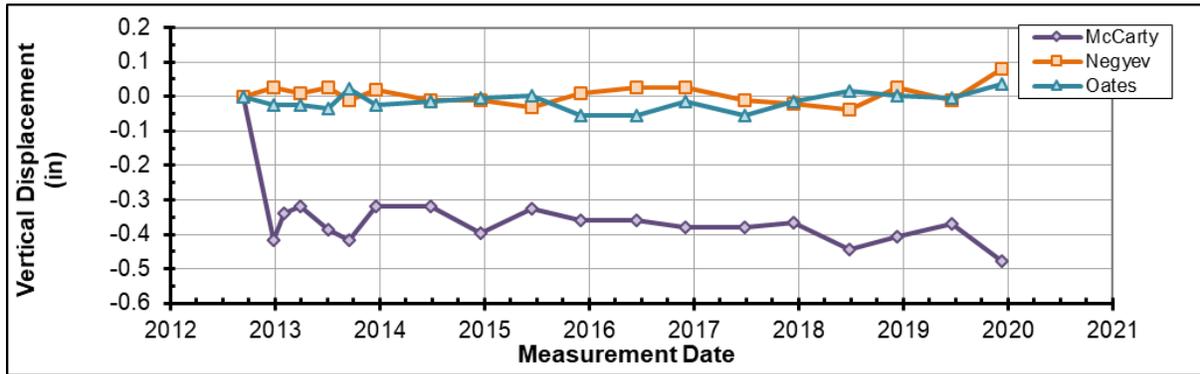
Figure 12. Fault Displacement over the 5.5 Year Monitoring Period at McCarty, Negyev, and Oates Faults

In 2012, three additional faults were instrumented for the lines that were constructed to connect the existing Longhorn line to East Houston. The three faults include the McCarty fault near Station 35+80, Negyev Fault near Station 140+00, and Oates Fault near Station 147+00. Baseline readings were taken for the McCarty, Negyev, and Oates faults in September 2012. After the baseline readings there have been 17 readings taken as shown in Figure 12.

The readings measured at the McCarty station from the baseline measurement in September 2012 to December 2012 indicated a jump of about one-half inch of displacement had occurred. No other large movement has been observed subsequent to the initial jump. This jump could be indicative of the benchmark equilibrating with its environment after installation or due to measurement error of the baseline reading. Since 2018, the resurveys show continuous movement above the average at McCarty and Negyev faults that require continuous monitoring. The movement at Oates fault during 2019 followed the average trend line.
