2014 Operational Reliability Assessment of the Longhorn Pipeline System

**2014 OPERATIONAL RELIABILITY ASSESSMENT OF THE LONGHORN PIPELINE
SYSTEM**

MAGELLAN PIPELINE COMPANY

March 31, 2016

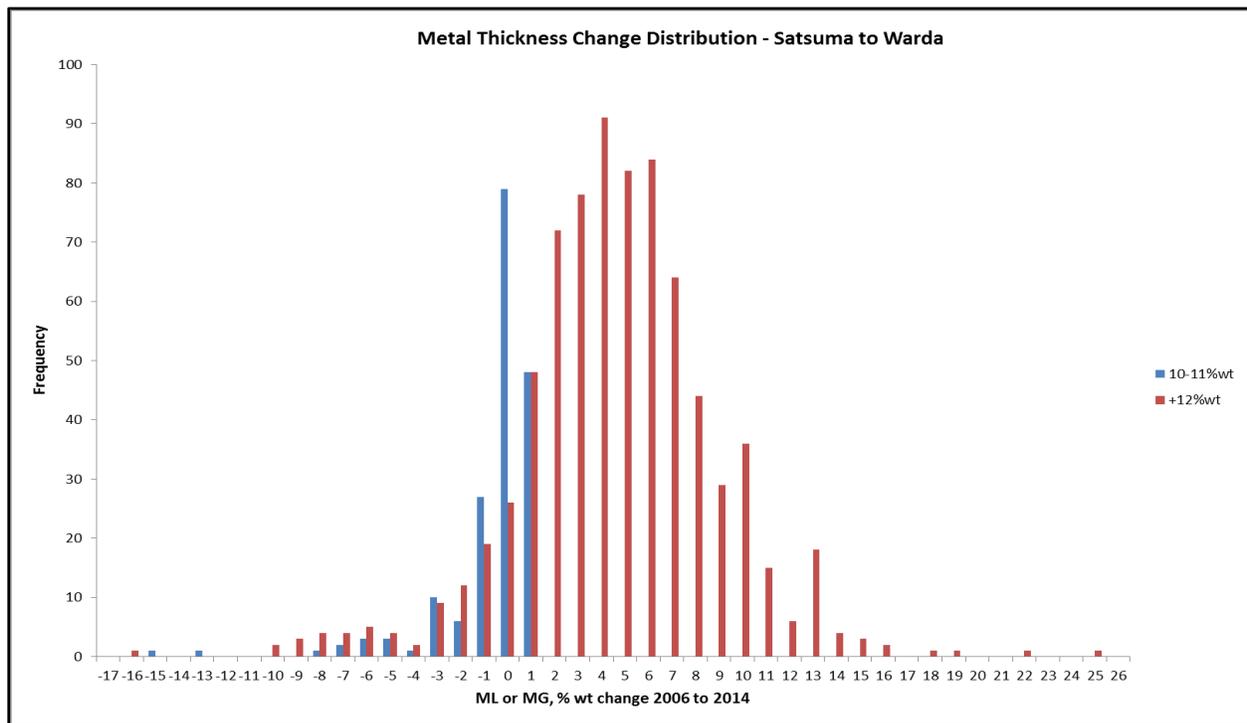
for the entire ILI run or it may indicate an ILI error. Figure 3 shows the goodness of fit for a normal distribution for features from the 2014 ILI assessment with a depth greater than 12%wt. Metal loss features with depths of 10 and 11%wt from the 2014 ILI assessment were not included in the CGR analysis due to the uncertainty of the accuracy of the 2006 assessment depths for these features.

Figure 3. Satsuma to Warda Histogram showing the distribution of metal loss/metal gain obtained from the 2006 to 2014 run comparison (953 data points)

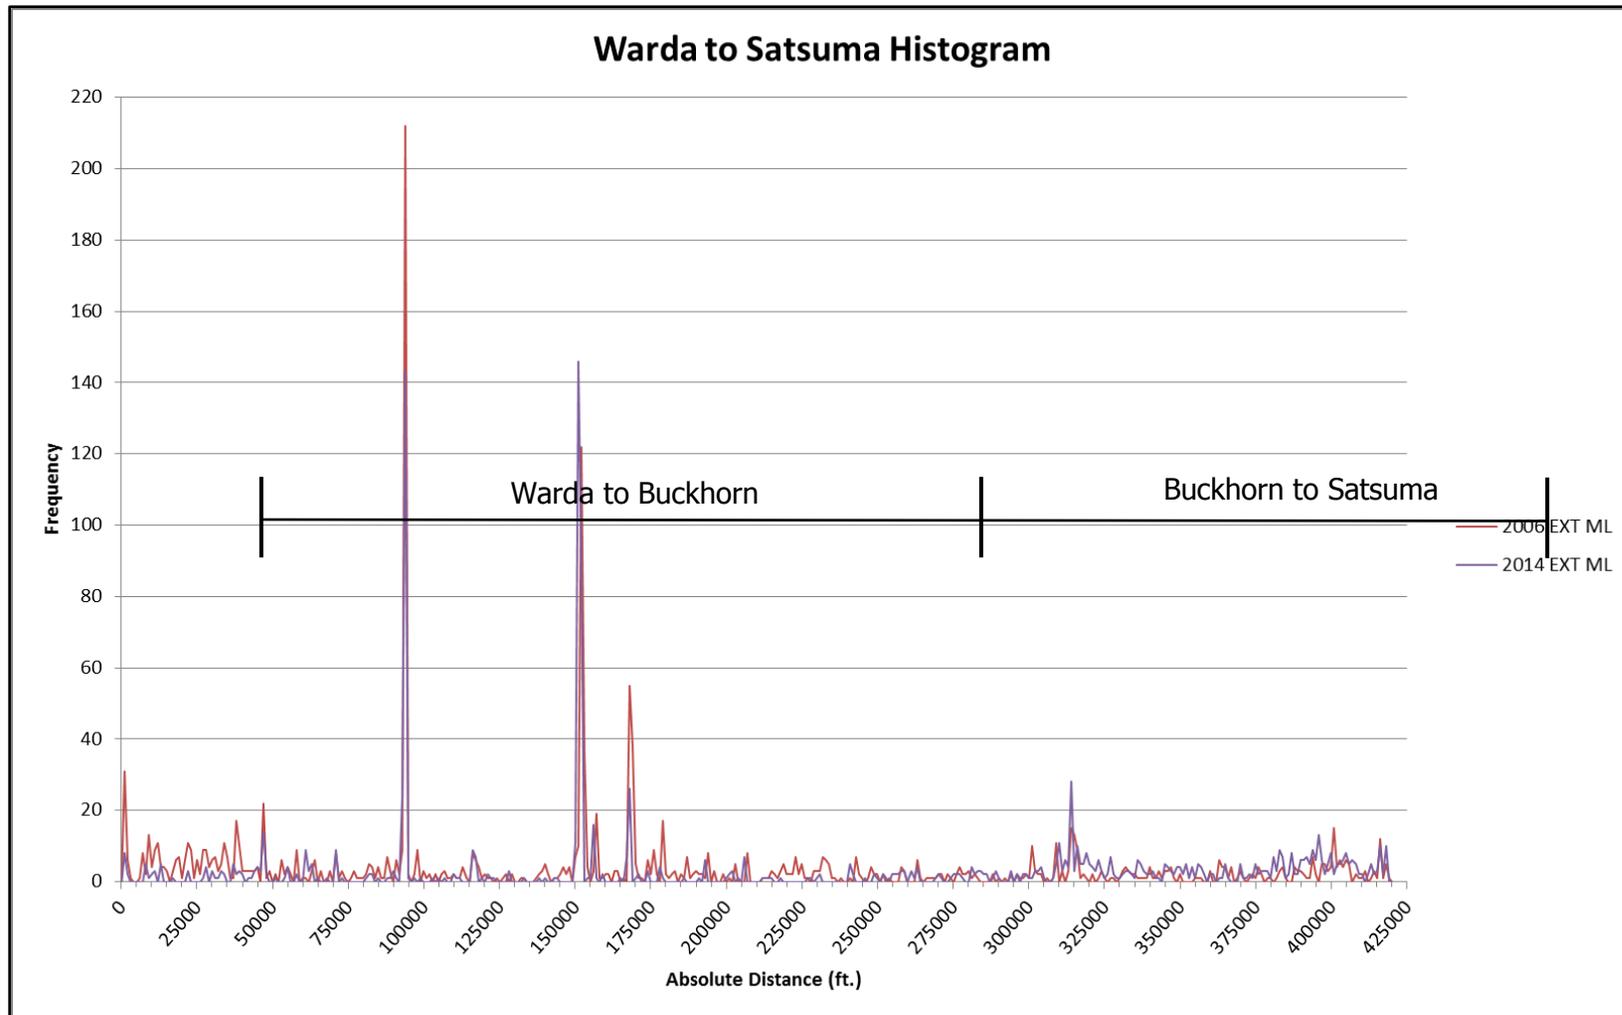
External corrosion growth rates along a pipeline should be expected to have the potential for variability along the length of pipeline due to differences in cathodic protection, coating conditions, pipe age, and environment. A histogram of metal loss frequency (occurrences or count) along the linear distance of the pipeline can give indication where metal loss features are more likely. A comparison of metal loss frequency histograms for the 2006 MFL assessment and the 2014 MFL assessment can be seen in Figure 4 for the Warda to Satsuma segment and in Figure 5 for the Satsuma to East Houston segment. Note, in Figure 4 and Figure 5 external metal loss features with depths less than 12%wt were excluded from the 2014 data. Both segments inspected in 2014 had a large amount of low metal loss features (less than 12%wt); Warda to Satsuma (2,155) and Satsuma to East Houston (1,904). A couple of possible explanations for the large amount of low metal loss features could be due to advancements in tool technology or could be that features were just below the 10%wt threshold in 2006 and are now just above the 10%wt threshold in 2014.

Figure 4. Warda to Satsuma metal loss frequency by linear distance along the pipeline (2006 MFL vs 2014 MFL data)

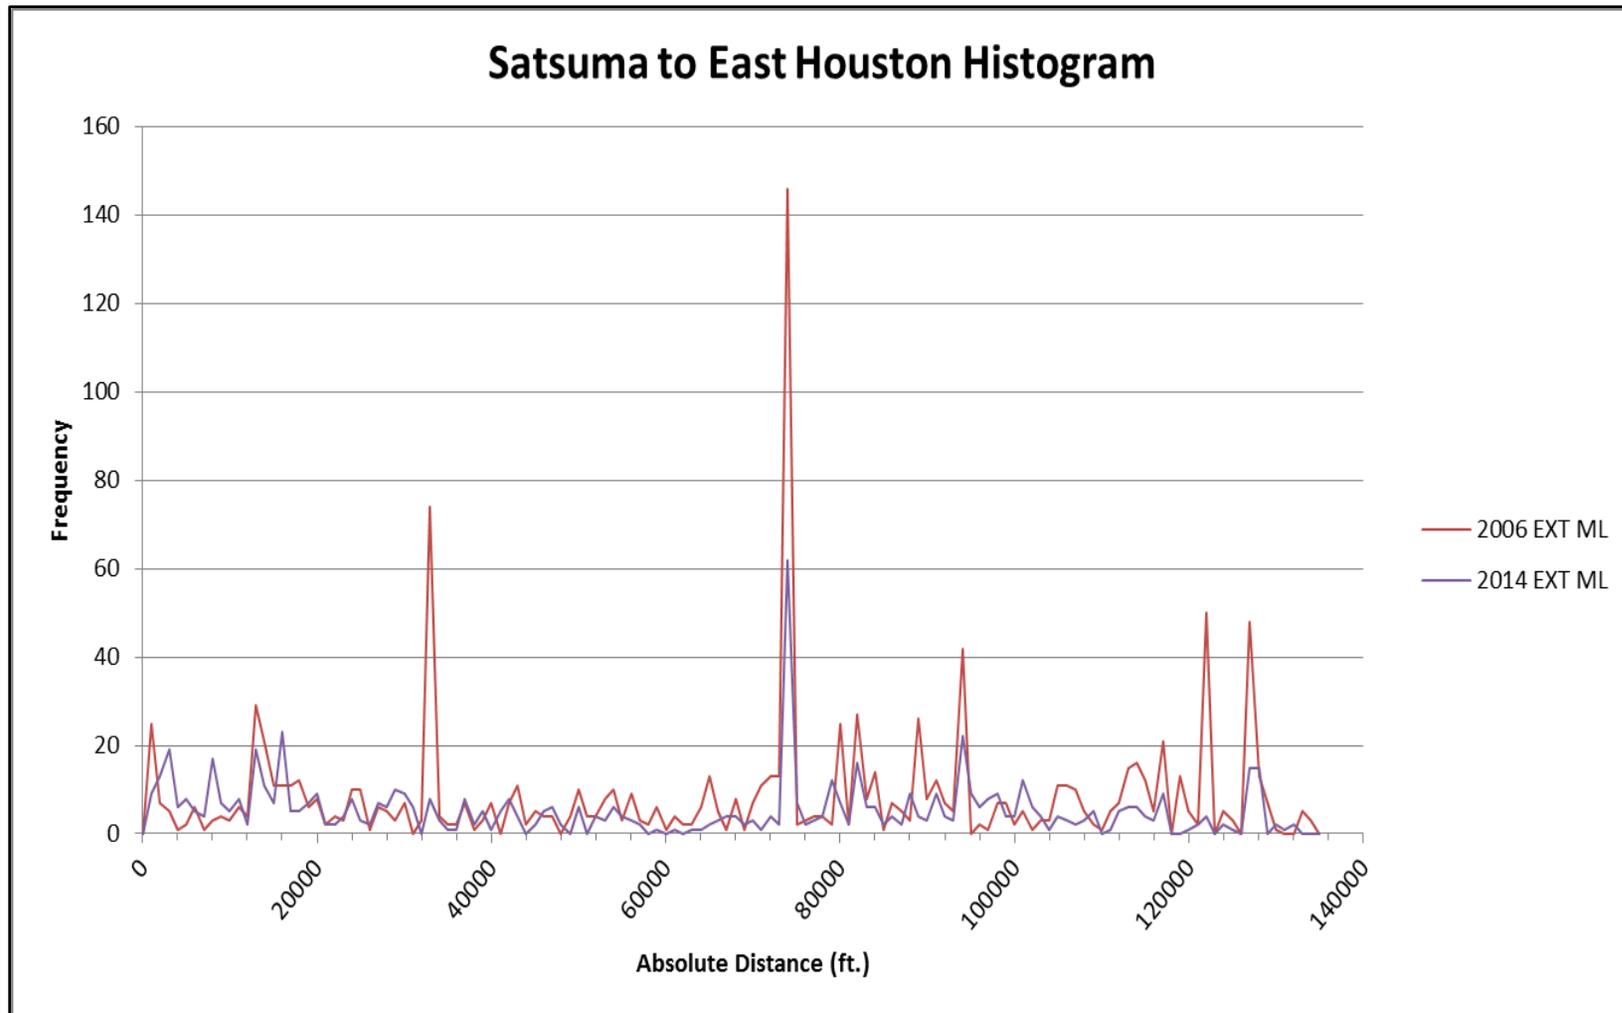
Figure 5. Satsuma to East Houston metal loss frequency by linear distance along the pipeline (2006 MFL vs 2014 MFL data)

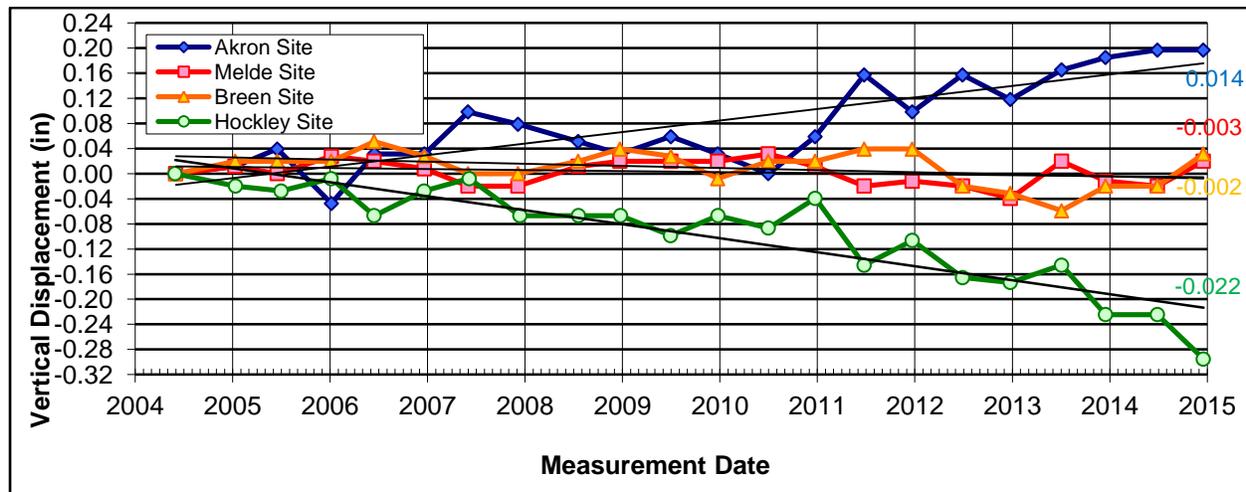
over time by calculating best fit trend lines. The trend lines show no measureable movement on the Melde and Breen Faults, with only slight movement of 0.014 in/yr (0.36 mm/yr) over 10½ years for the Akron Fault and -0.022 in/yr (-0.56 mm/yr) over 10½ years for the Hockley Fault.

Figure 6. Fault Displacement over 11-Year Period at Akron, Melde, Breen and Hockley Faults

For this year’s analysis of 11 years of data, we used the calculated movement from the best fit trend lines and compared these estimates of fault growth to the Kiefner stress analysis described in the 2005 ORA Annual Report. Assumptions used in the 2005 analysis included: the allowable stress levels based on the latest version of ASME B31.4 available at that time; the stress resulting from regular operation (instead of fault movement) in the pipeline was determined by ASME B31.4 stress analysis; the soil properties were from our best estimate for representative values of properties obtainable and the fault movement rates were represented by linear trend lines fit to the data. Table 7 shows the amount of movement at each fault that can occur before it exceeds the stress levels determined by the 2005 analysis. The differences in allowable fault displacements are caused in a large part by differences in the angles of the fault movement. The calculated rate of displacement has accelerated and reduced the number of years to reach the allowed displacement from the amount reported in the first half of 2013 Report (Table 6). It should be noted that the “time to reach displacement (yrs)” in the last column is the total time from when the pipe is free of stress resulting from fault movement to the final failure. The limited number of years for Hockley Fault fell below the life of the pipeline segment at the region which was installed in the 1950s. If the fault has moved at an average rate of 0.022 in/yr since the installation, the stress should have failed according to the criterion from 2005 analysis. An updated analysis, criterion, and recommendations at Hockley Fault are provided at the end of this section. The other three faults have reinspection times of 250+ years. Such long times to reach a displacement that

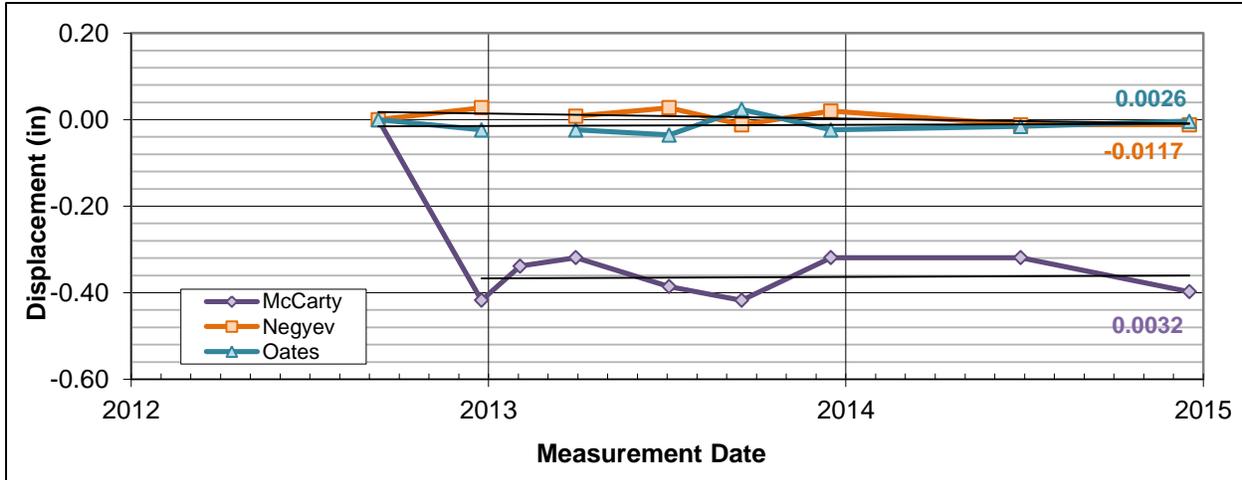
Three additional faults have been instrumented for the lines that were constructed to connect the existing Longhorn line to East Houston in 2012. The three faults include the McCarty Fault near Station 35+80, Negyev Fault near Station 140+00, and Oates Fault near Station 147+00. Baseline readings were taken for the McCarty, Negyev, and Oates faults in September 2012. After the baseline readings there have been five readings performed within approximately one year as shown in Figure 7. The trend line for Negyev and Oates show no movements. At the McCarty Fault, there is a significant jump of about ½ inch between the baseline reading and the first reading point; no movement was observed from the readings after the first reading point. As a result, the jump at the first reading point is very likely due to the false baseline reading. The allowable fault displacement at the three faults was determined as described below which would provide monitoring references as those listed in Table 4 for the other four faults.

Figure 7. Fault Displacement over 1-Year Period for McCarty, Negyev and Oates

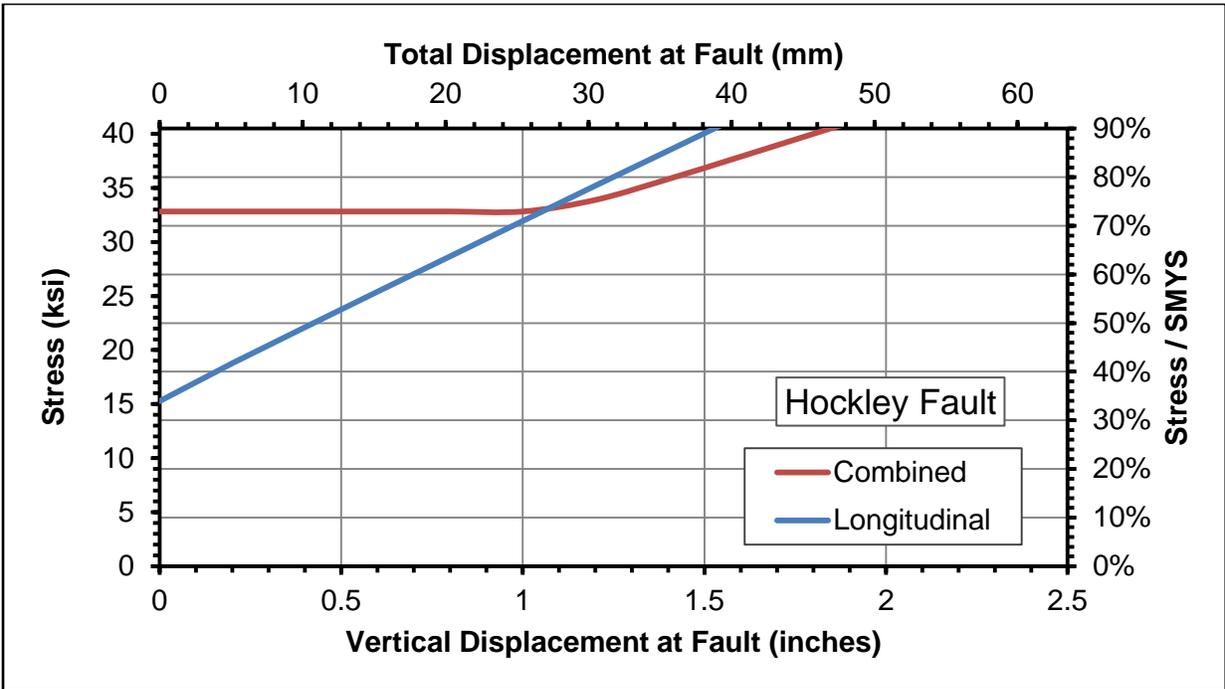
Table 9 summarizes the updated allowable displacement at Hockley Fault and the newly estimated allowable displacement at McCarty, Negyev and Oates faults. The years from no stress resulting from fault movement to failure was also provided based on the average fault movement rate as determined from Figure 6 and Figure 7.

Figure 8. Longitudinal Stress and Combined Biaxial Stress in Pipes at Hockley Fault with Different Fault Displacement

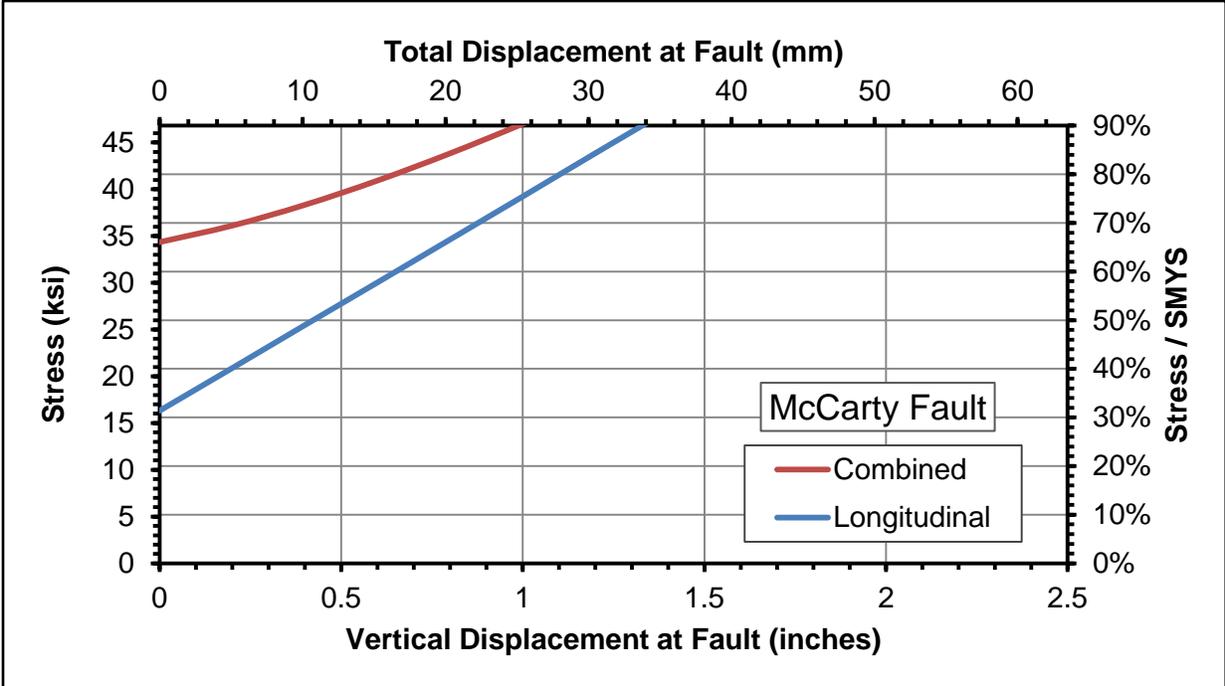
Figure 9. Longitudinal Stress and Combined Biaxial Stress in Pipes at McCarty Fault with Different Fault Displacement

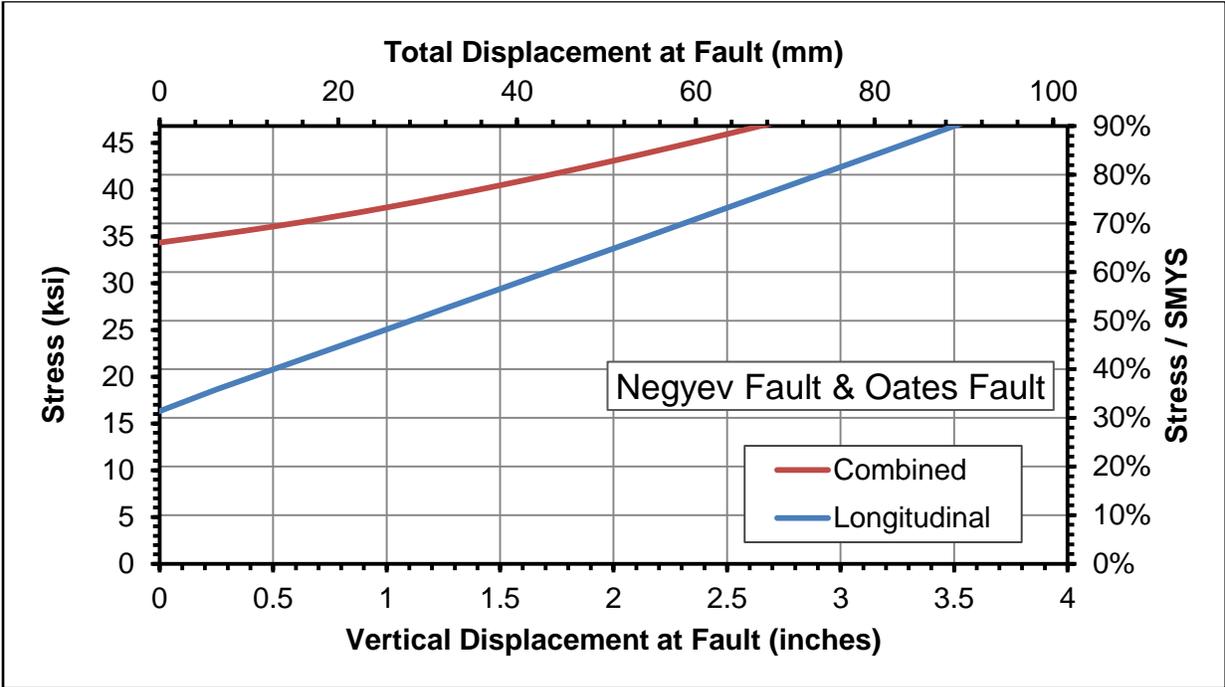
Figure 10 shows the total stress variations with the increase of displacement at Negyev Fault and Oates Fault. The two faults are close to each other and the pipe dimensions and buried depth are also identical. Therefore, the same stress variation was estimated at the two faults. The allowable fault displacement at the two faults is 2.65 inches.

Figure 10. Longitudinal Stress and Combined Biaxial Stress in Pipes at Negyev Fault and Oates Fault with Different Fault Displacement

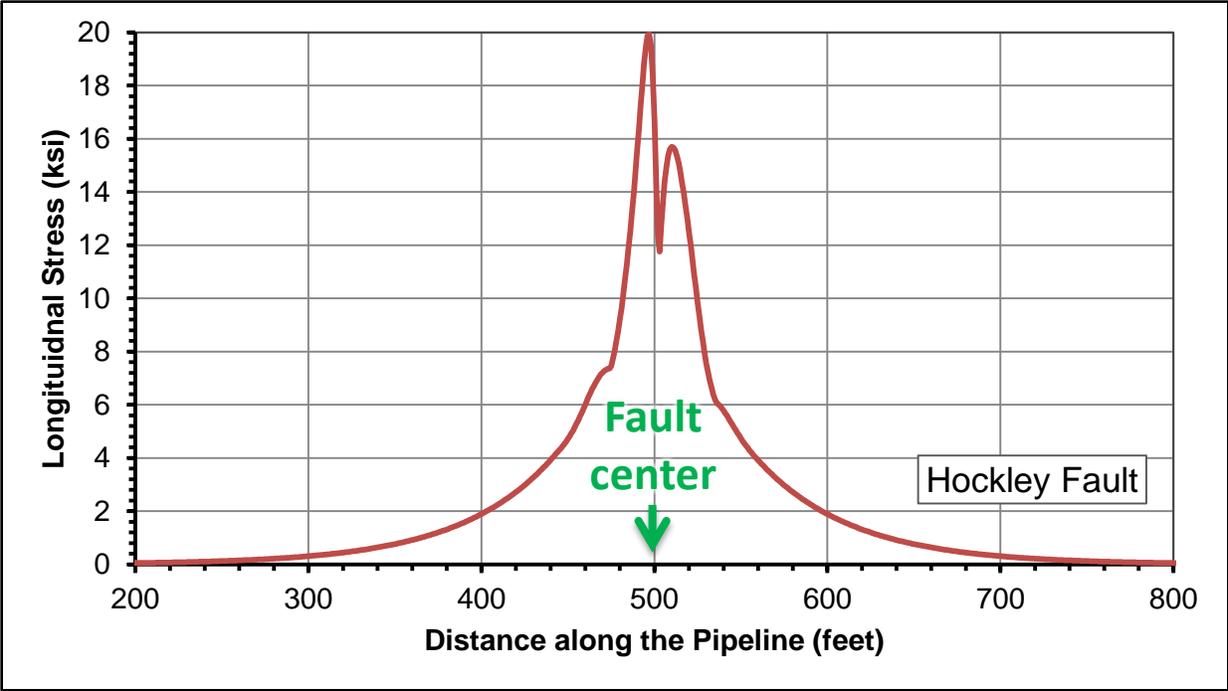
Figure 11. Distribution of the amplitude of longitudinal stress resulting from fault movement at Hockley Fault

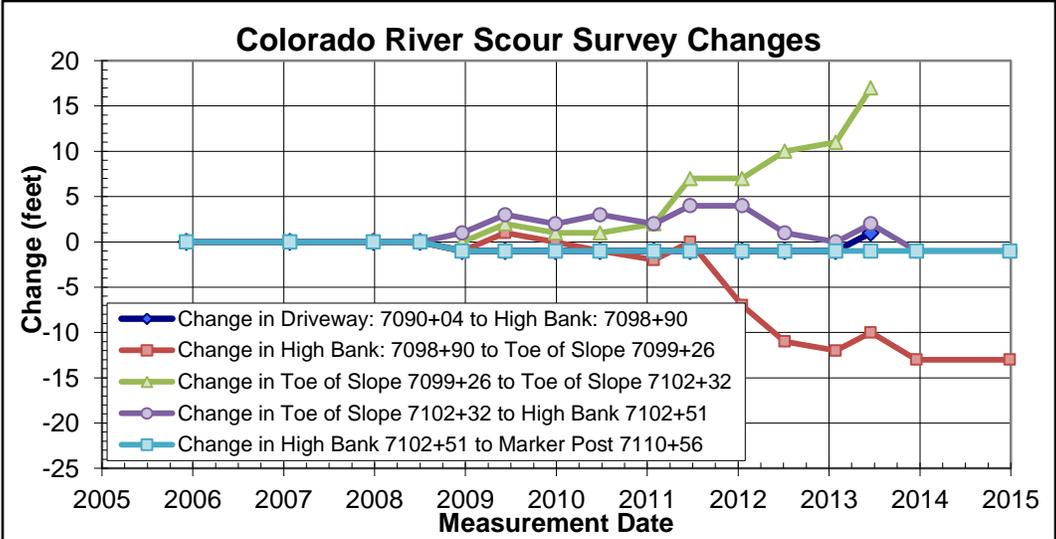
There are many stream crossings on the Longhorn system, with all but two needing inspections once every five years according to studies generated by LMC 19(b) and covered in the ORA by section 6.3 of the ORAPM. The potential for failure was summarized in Appendix 9E of the original 2000 EA. The Colorado River (Figure 12) and its tributary Pin Oak Creek (Figure 13) were last surveyed in December 2014. The results show changes in the High Bank to the Toes on Pin Oak Creek of 6.0 feet and changes on the west Bank of Colorado River between Toe and High Bank of 2.0 feet. Both of them kept the same level as those in 2013 ORA.

Figure 12. Changes in the Scour Survey of the Colorado River over 8 Years

These changes in the distance from the High Bank to the Toes of Pin Oak Creek and the distance between the Toes and the distance from the West High Bank to the Toe of the Colorado River warrant a more accurate survey of the depth of burial of the pipeline in the river bed between the Toes of the two bodies of water to determine how much depth of cover loss is acceptable.

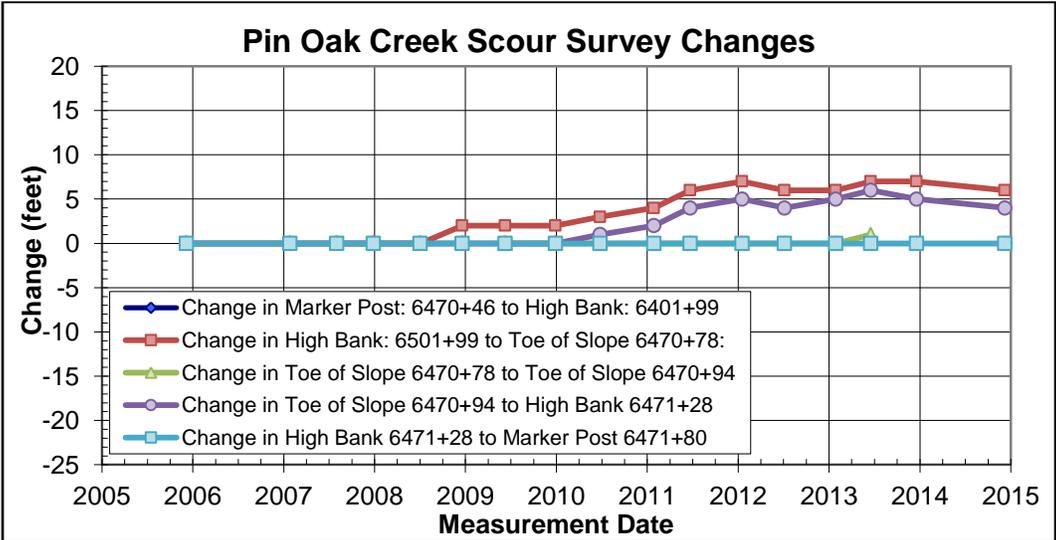
Figure 13. Changes in the Scour Survey of Pin Oak Creek over 8 Years
