2017 Operational Reliability Assessment of the Longhorn Pipeline System

Susan Rose, Adam Steiner, PE, Benjamin Wright,
Benjamin Zand, PhD, PE and Dennis Johnston
March 28, 2019

Final Report

MAGELLAN PIPELINE COMPANY

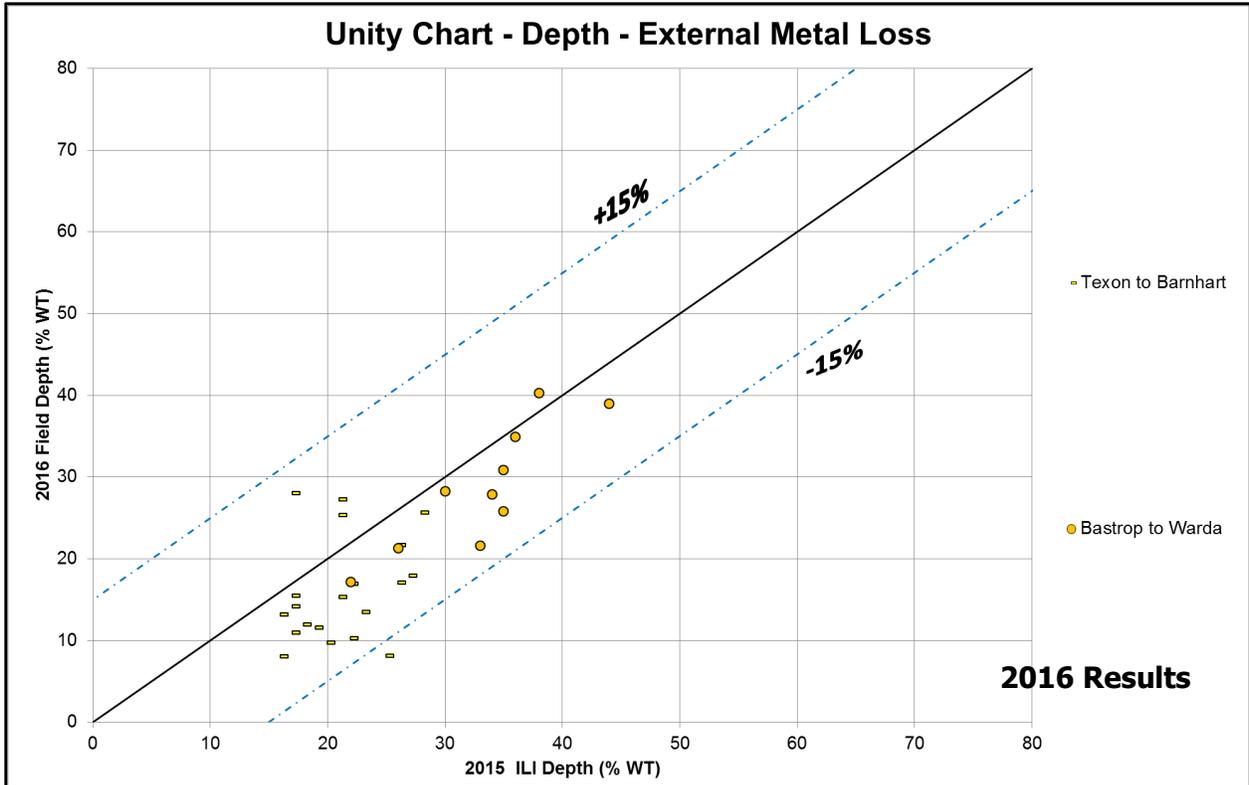
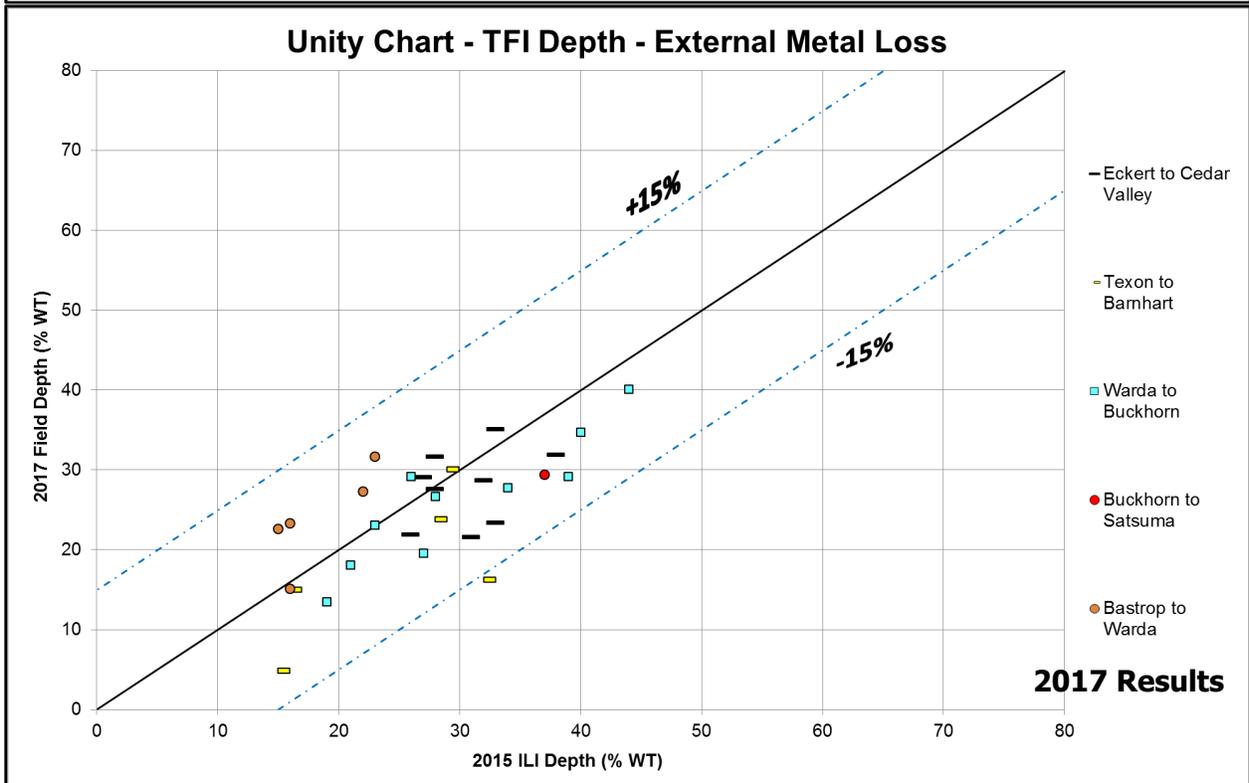
Figure 7. Unity Chart for Depth Verification for TFI External Metal Loss (Upper Bound $\pm 15\%$ WT)

Figure 9 demonstrates the difference between the ILI predicted and in-ditch depth based on a normal distribution for all correlated external metal loss features. Ideally, a cumulative fraction curve of 0.5 will be 0% WT as shown in $\pm 15\%$ WT for 80% of the data. The cumulative fraction curve for the best fit data shows that the 2016/2017 combined ILI assessment has an overcall of approximately 4.8% WT. The curve indicates that the tool is performing better than specification if bias is accounted for. If the bias is accounted for, the tool is performing better than specification at $\pm 8.0\%$ WT

One recommendation to consider for future in-ditch anomaly investigations came from the review of the 2017 maintenance and NDE reports. This recommendation is to use advanced NDE methodologies that have a high resolution for in-ditch evaluations to help characterize and size anomalies that are within the pipe body.

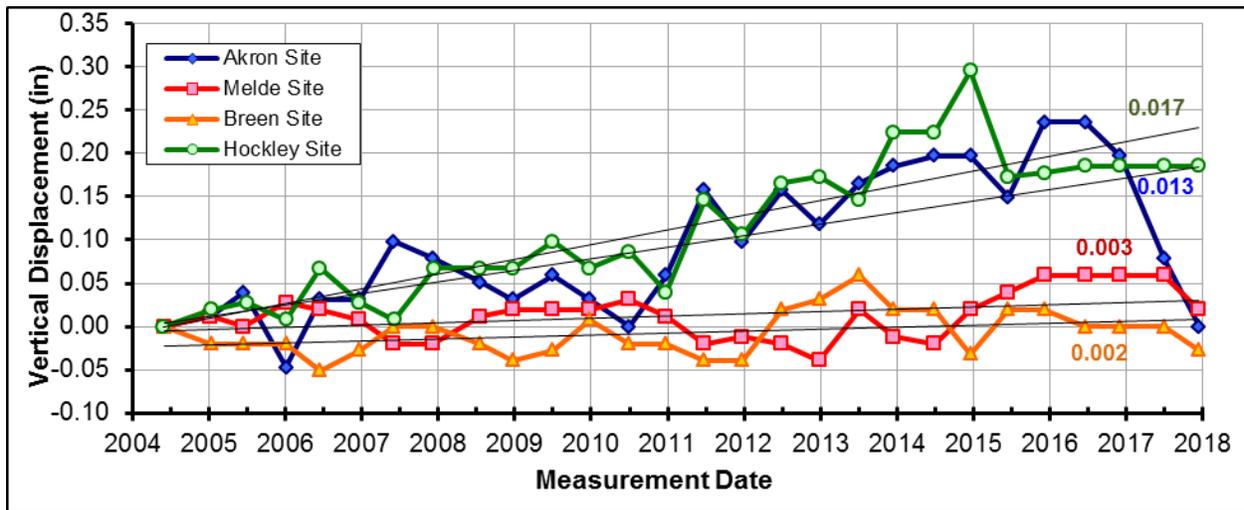
Figure 10. Fault Displacement over 13.5-Year Period at Akron, Melde, Breen and Hockley Faults

Kiefner conducted the original stress analysis to determine the maximum allowable displacements at the Akron, Melde, Breen and Hockley faults in the 2005 ORA Annual Report. Assumptions used in the 2005 analysis included: the allowable stress levels based on the version of ASME B31.4¹⁰ available at that time; the stress resulting from regular operation (instead of fault movement) in the pipeline was determined by ASME B31.4 stress analysis; the

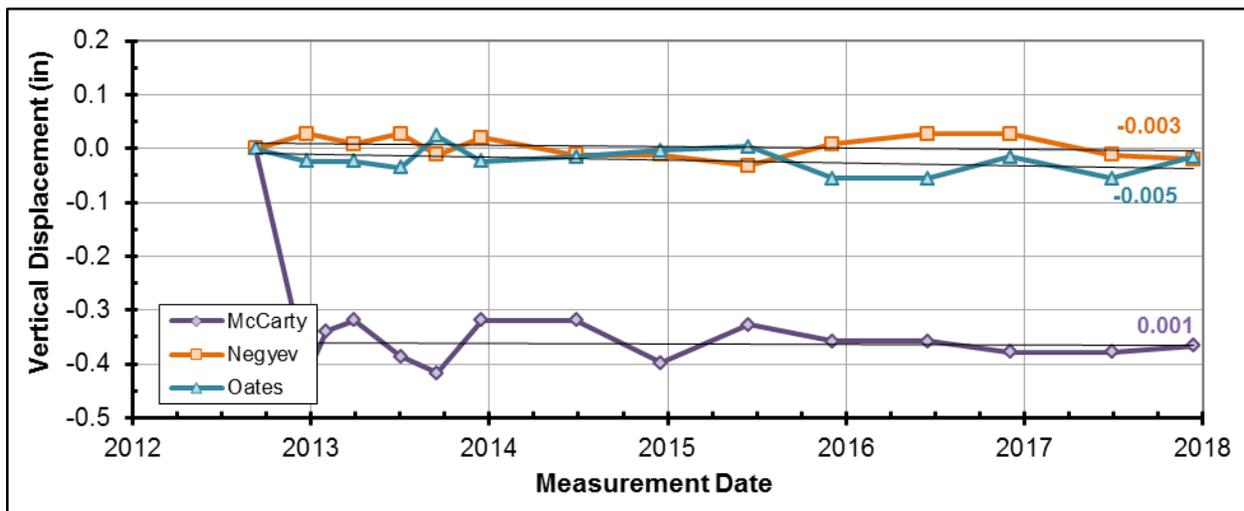
Figure 11. Fault Displacement over 5-Year Period for McCarty, Negyev and Oates

Three additional faults have been instrumented for the lines that were constructed to connect the existing Longhorn line to East Houston in 2012. The three faults include the McCarty Fault near Station 35+80, Negyev Fault near Station 140+00, and Oates Fault near Station 147+00. Baseline readings were taken for the McCarty, Negyev, and Oates faults in September 2012. After the baseline readings there have been 13 readings taken as shown in Figure 11. The trend lines for the Negyev and Oates faults show no movement. At the McCarty Fault, there is a jump of about one-half inch between the baseline reading and the first reading point though

no movement was observed subsequent to the initial jump. The jump at the first reading point is likely due to measurement error of the baseline reading.
