2015 Operational Reliability Assessment of the Longhorn Pipeline System

**2015 OPERATIONAL RELIABILITY ASSESSMENT OF THE LONGHORN PIPELINE
SYSTEM**

MAGELLAN PIPELINE COMPANY

March 28, 2017

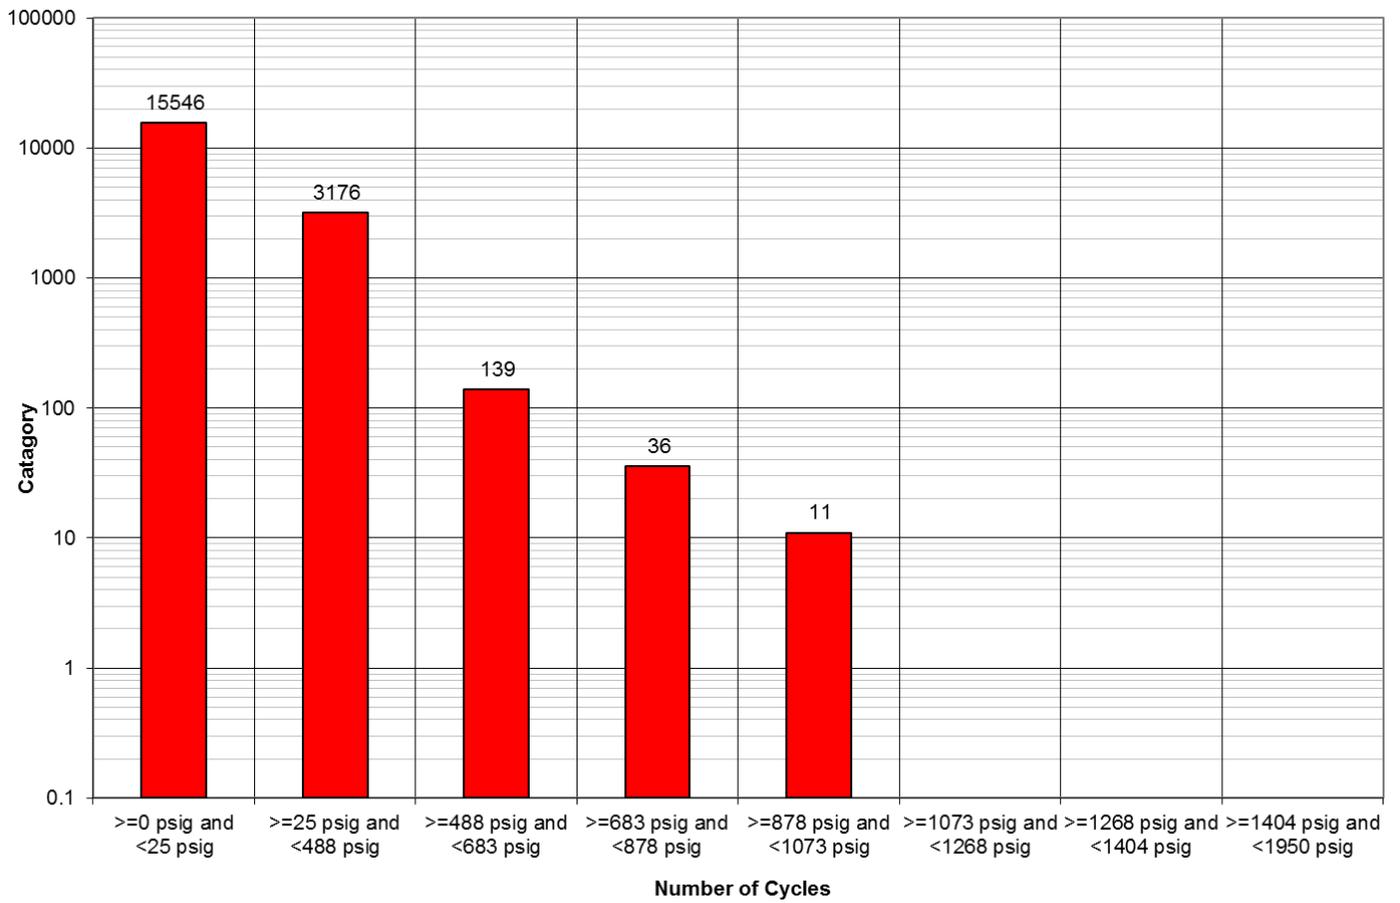
Figure 5. Pressure Cycles at Bastrop Station in 2015

The analysis showed that the shortest time to failure for a possible feature that could have been missed by the 2007-2008 TFI tool run is 14.7 years (from November 1, 2013) at the location that is now the Bastrop Station Discharge. The recommended reassessment interval is calculated by taking 45% of the shortest fatigue life, which corresponds to a factor of safety of 2.22 (1/0.45). Applying this factor of safety, a reassessment interval of 6.6 years (from November 1, 2013) is recommended based on the current operating pressures. An assessment would be required in 2020 for the Warda to Bastrop and Buckhorn to Warda segments. For all thirteen TFI-detected Seam Weld B features found during the 2015 TFI, the calculated fatigue life is greater than for a tool detection threshold sized anomaly at the worst-case location in the respective segments. Therefore, the detection threshold anomalies determine the appropriate reassessment intervals. Assessments for the other segments would be required between 2023 and 2238, as stated in Section 3.1. The pressure cycling frequency decreased in 2015 for all segments except the Satsuma to East Houston segment, when compared to 2014 which resulted in a longer time until reassessment for segments which were not reassessed in 2015. Figure 5 displays the pressure cycles at the Bastrop Station discharge during 2015. Figure 6 displays the pressure cycles at the Bastrop Station discharge during 2014. These figures are representative of pressure cycling in the Crane to Satsuma segments.

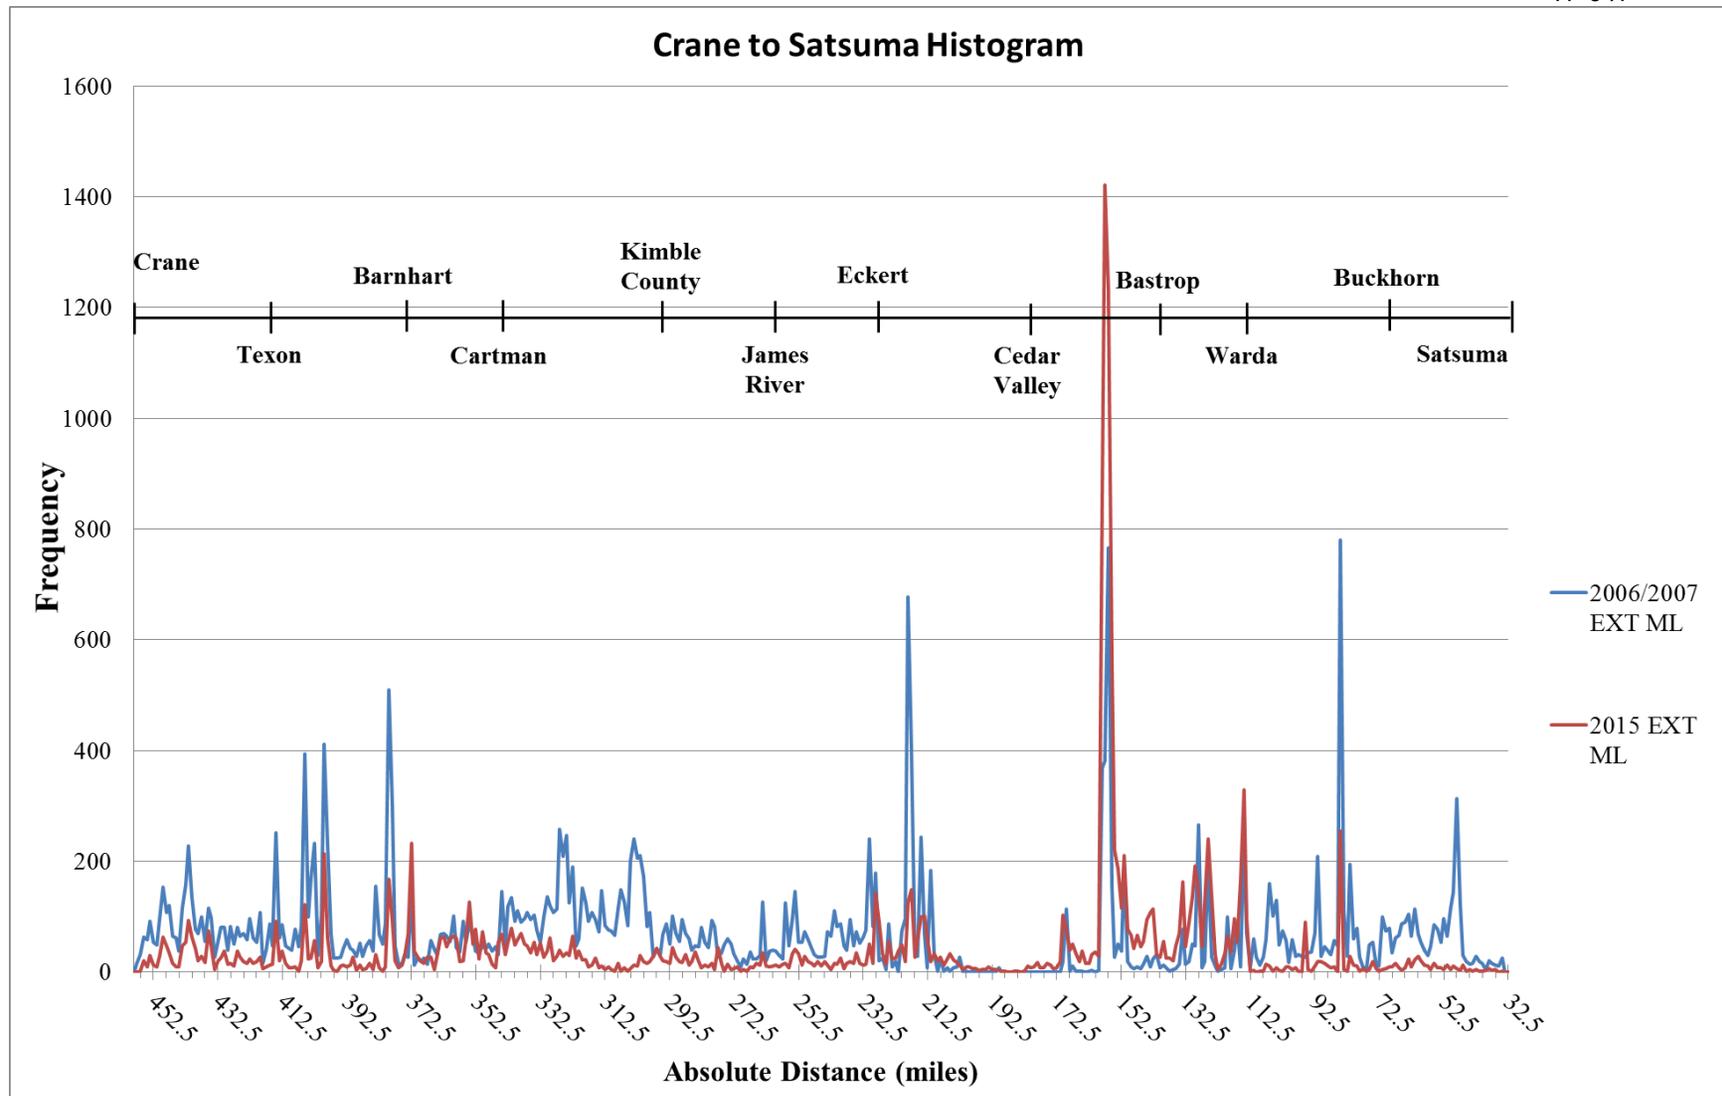
Figure 8. Crane to Satsuma External Metal Loss Frequency by Linear Distance along the Pipeline (2006/2007 MFL vs 2015 MFL Data)

External CGRs along a pipeline should be expected to have the potential for variability along the length of pipeline due to differences in cathodic protection, coating conditions, pipe age, and environment. A histogram of metal loss frequency (occurrences or count) along the linear distance of the pipeline can give indication where external metal loss features are more likely. A comparison of external metal loss frequency histograms for the 2006/2007 MFL and TFI assessments and the 2015 MFL and TFI assessments can be seen in Figure 8 for Crane to Satsuma. Note that a couple of possible explanations for the increase of metal loss features in 2015 could be due to advancements in tool technology or could be low level metal loss features that were just below the 10%wt threshold in 2006/2007 and are now just above the 10% WT threshold in 2015.

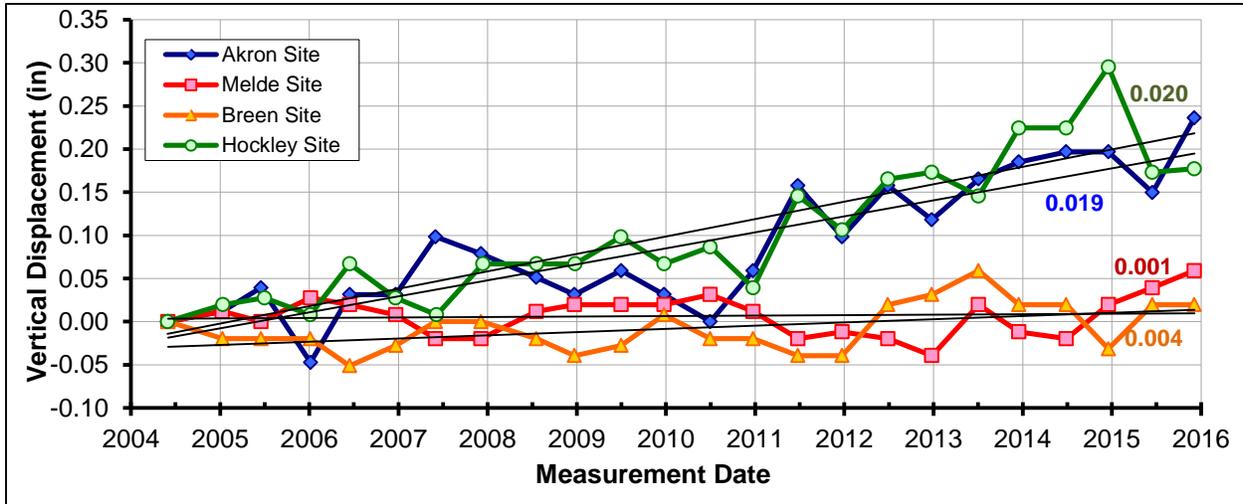
Figure 9. Fault Displacement over 12-Year Period at Akron, Melde, Breen and Hockley Faults

Monitoring stations across the four faults were installed in March 2004 in accordance with Section 6.2 of the ORAPM. Baseline readings were taken in late May and early June, 2004. Twenty-three subsequent displacement readings have been taken at approximately 6-month intervals. A plot of the vertical displacements over time is shown in Figure 9. Faults move in one direction only, so the up and down variability is an indication of the uncertainty of the measurement. Using nearly 12 years of data an attempt was made to measure the actual fault movement over time by calculating best fit trend lines. The trend lines show no measureable movement on the Melde and Breen Faults, with only slight movement of 0.019 in/yr (0.47 mm/yr) over 11½ years for the Akron Fault and 0.020 in/yr (0.51 mm/yr) over 11½ years for the Hockley Fault.

- Because of this slow rate of fault movement, Kiefner recommends a five-year reassessment rather than the current semi-annual program, except for the Hockley fault.

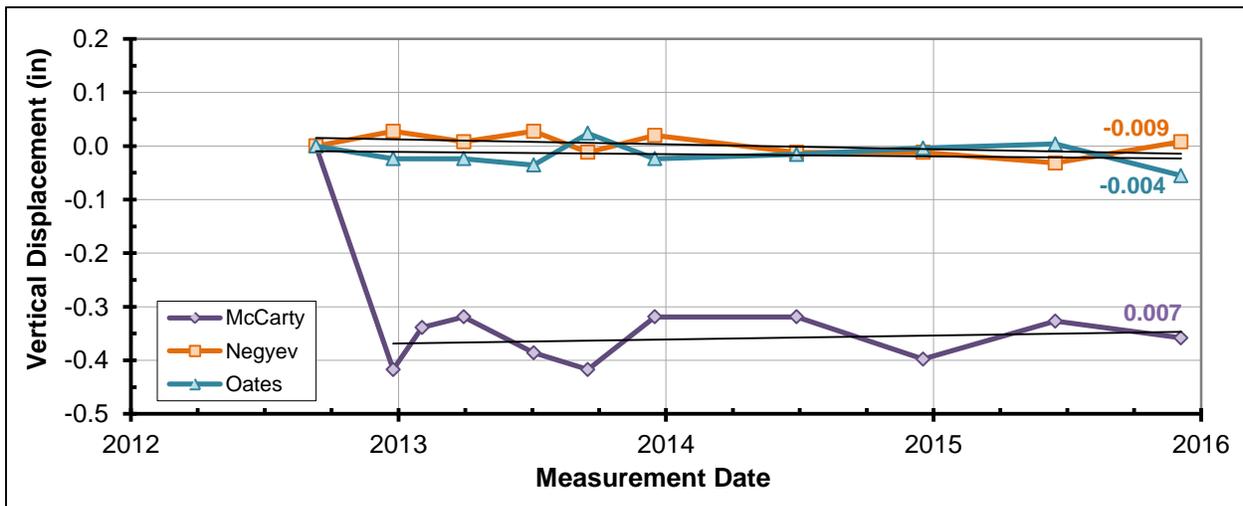
Figure 10. Fault Displacement over 3-Year Period for McCarty, Negyev and Oates

Three additional faults have been instrumented for the lines that were constructed to connect the existing Longhorn line to East Houston in 2012. The three faults include the McCarty Fault near Station 35+80, Negyev Fault near Station 140+00, and Oates Fault near Station 147+00. Baseline readings were taken for the McCarty, Negyev, and Oates faults in September 2012. After the baseline readings there have been nine readings taken as shown in Figure 10. The trend lines for the Negyev and Oates faults show no movement. At the McCarty Fault, there is a significant jump of about one-half inch between the baseline reading and the first reading point; no movement was observed from the readings after that. The jump at the first reading point is very likely due to a false baseline reading.

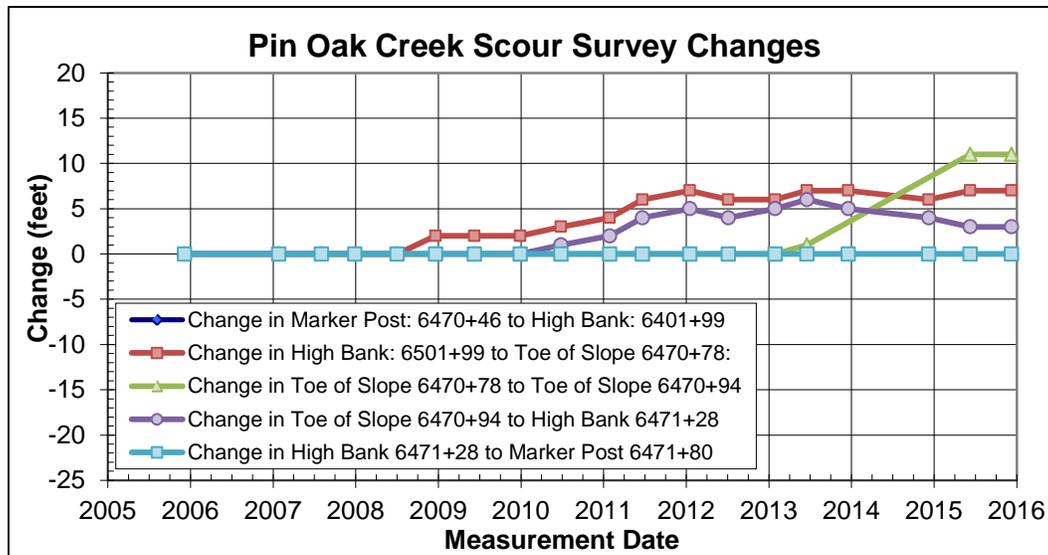
Figure 12. Changes in the Scour Survey of Pin Oak Creek over 8 Years

As shown in Figure 12 for the Pin Oak Creek crossing, no movement of bank locations was detected from the constant distance between the Marker Post at 6470+46 and the East High Bank at 6501+99 and the constant distance between the West High Bank at 6471+28 and the Marker Post at 6471+80. The distance between East High Bank and the toe of the slope increased by one foot and the distance between the West High Bank and the toe of the slope decreased by one foot in 2015. The distance between the toes at the two slopes also increased considerably compared to the last measurement in the summer of 2013. The changes were expected due to the large amount of rainfall in 2015.

Magellan is committed to continue conducting two inspections per year at the two crossings and monitoring the depth of cover of the pipeline and scouring of the banks.
