2018 Operational Reliability Assessment of the Longhorn Pipeline System

March 25, 2020

**2018 OPERATIONAL RELIABILITY ASSESSMENT OF THE LONGHORN PIPELINE
SYSTEM**

MAGELLAN PIPELINE COMPANY

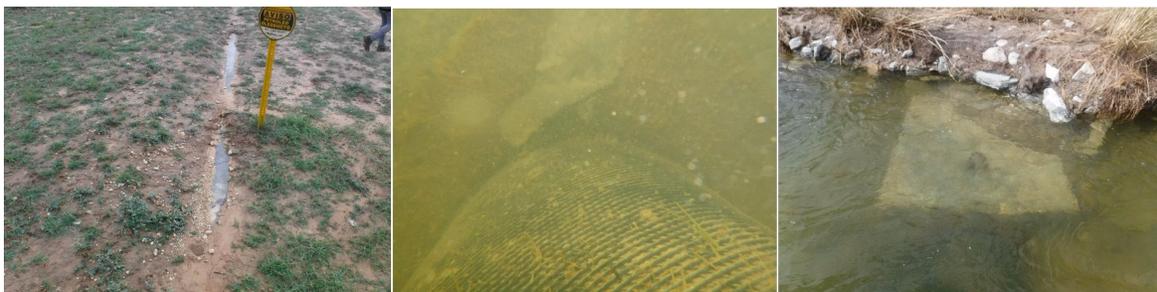
Figure 12. James River Inspection, 2018²⁰

The James River and Llano River waterways were inspected in 2018. At the Llano River, the pipeline was not exposed but the cover depth was reported at 1.5 ft (maximum was 4.5 ft). Engineering drawings appear to indicate the cover has been washed away even though the bedding is made of rock. Kiefner expects monitoring of the Llano River waterway for the Longhorn pipeline to be repeated in 2020. The inspection report also indicates the river banks are stable. At the James River, the inspection report indicates 28 ft of exposed pipeline with 14 ft suspended with exposed river weight. No remediation has been reported. Kiefner recommends revisiting the locations with exposed pipe, establish whether the exposure has been a temporary event or has become permanent. If the status at James River crossing has been a temporary event, then it is suggested to establish whether it can occur again. If pipe exposure is as before, then sand bags, re-establishing cover, protective mats are recommended.

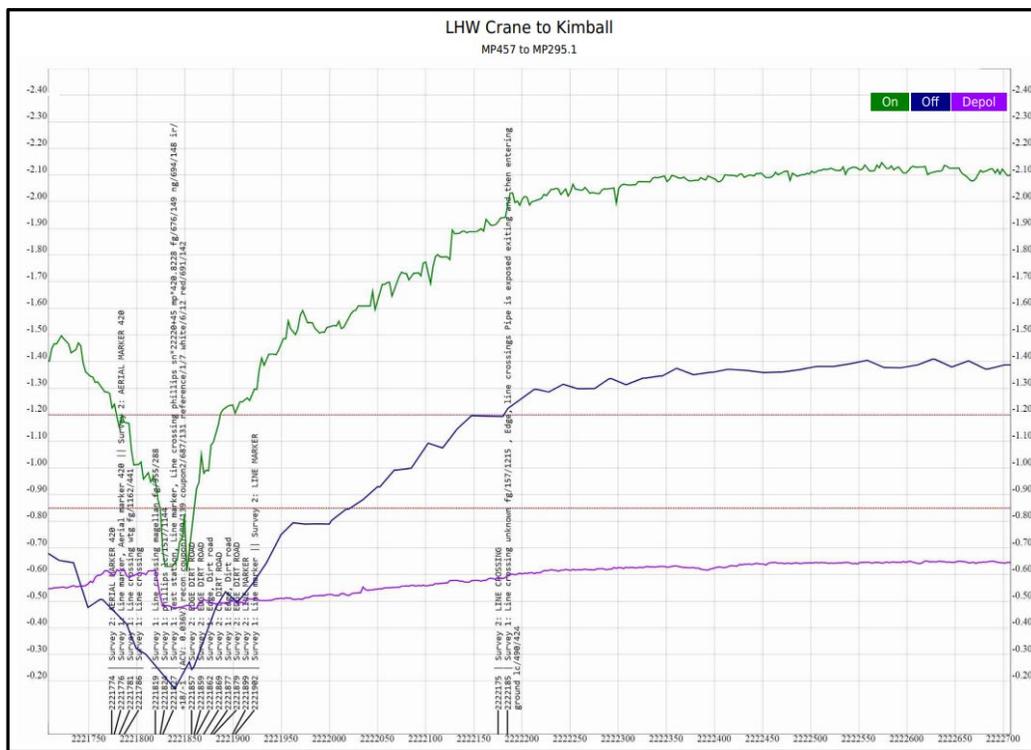
Figure 13. Location of Crane to Kimball not Meeting Any Criteria

The 2018 CIS data also indicate that most of the pipe sections show the “instant off” readings slightly more electronegative than -1200 mV with respect to a CSE reference electrode, meaning these pipe sections may be overprotected by the CP system. Over cathodic polarization on the pipe may cause external coating blister or damage.
