2019 Operational Reliability Assessment of the Longhorn Pipeline System

Final Report

Magellan Pipeline Company

Kiefner and Associates
1608 S. Duff, Suite 400
Ames, IA 50010

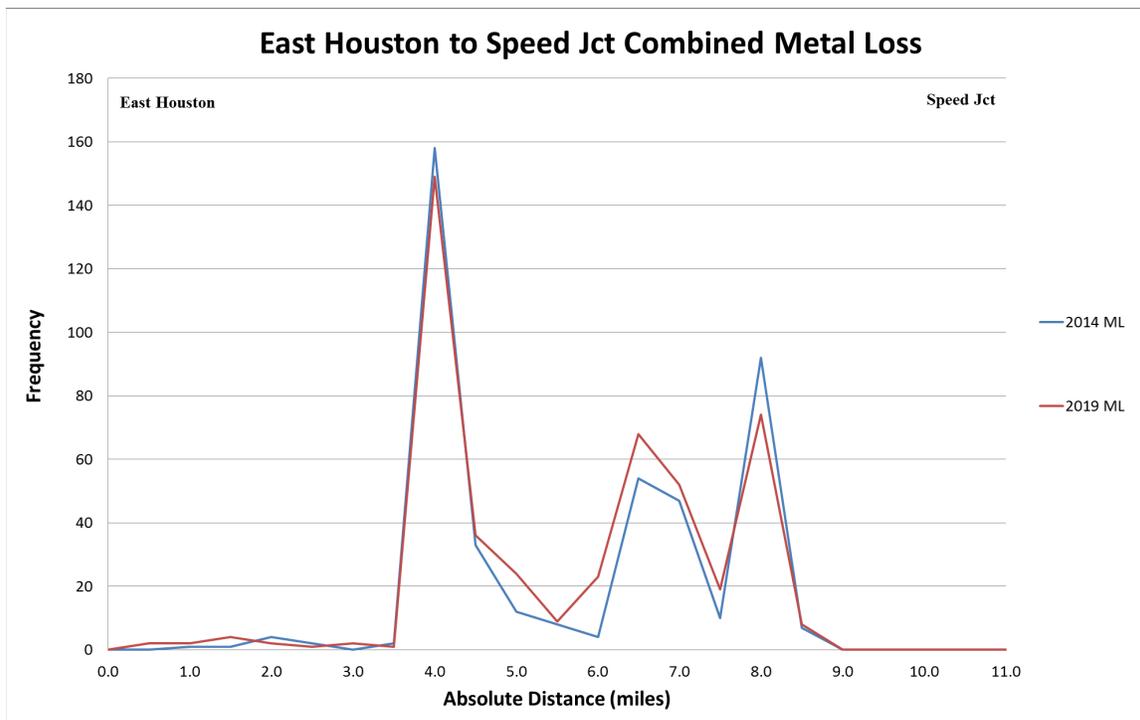
Figure 7. East Houston to Speed Jct Combined ML Frequency by Linear Distance along the Pipeline (2014 MFL vs 2019 MFL)

- Figure 6 and Figure 7 shows histograms for East Houston to Speed Jct; Figure 6 shows the external and internal ML features broken out separately while Figure 7 shows the external and internal ML features combined. Figure 7 indicates the ML count between assessments is similar and that there is a difference in how external and internal features were reported between the two assessments. There are 49 internal ML features from the 2019 assessment that correlate with external ML features from 2014.
