2015 Operational Reliability Assessment of the Longhorn Pipeline System

**2015 OPERATIONAL RELIABILITY ASSESSMENT OF THE LONGHORN PIPELINE
SYSTEM**

MAGELLAN PIPELINE COMPANY

March 28, 2017

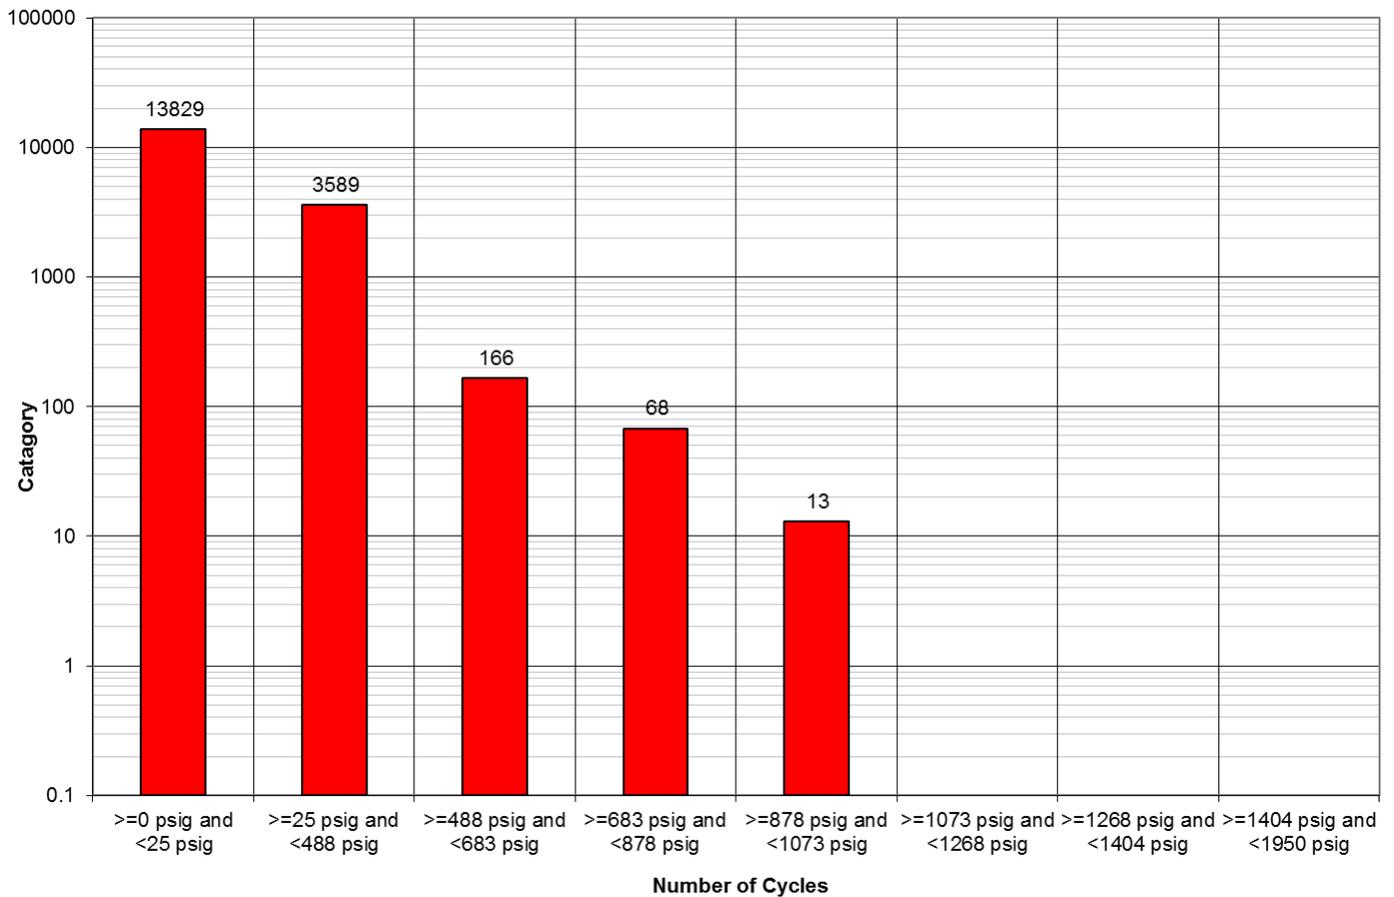
Figure 6. Pressure Cycles at Bastrop Station in 2014

The analysis showed that the shortest time to failure for a possible feature that could have been missed by the 2007-2008 TFI tool run is 14.7 years (from November 1, 2013) at the location that is now the Bastrop Station Discharge. The recommended reassessment interval is calculated by taking 45% of the shortest fatigue life, which corresponds to a factor of safety of 2.22 (1/0.45). Applying this factor of safety, a reassessment interval of 6.6 years (from November 1, 2013) is recommended based on the current operating pressures. An assessment would be required in 2020 for the Warda to Bastrop and Buckhorn to Warda segments. For all thirteen TFI-detected Seam Weld B features found during the 2015 TFI, the calculated fatigue life is greater than for a tool detection threshold sized anomaly at the worst-case location in the respective segments. Therefore, the detection threshold anomalies determine the appropriate reassessment intervals. Assessments for the other segments would be required between 2023 and 2238, as stated in Section 3.1. The pressure cycling frequency decreased in 2015 for all segments except the Satsuma to East Houston segment, when compared to 2014 which resulted in a longer time until reassessment for segments which were not reassessed in 2015. Figure 5 displays the pressure cycles at the Bastrop Station discharge during 2015. Figure 6 displays the pressure cycles at the Bastrop Station discharge during 2014. These figures are representative of pressure cycling in the Crane to Satsuma segments.

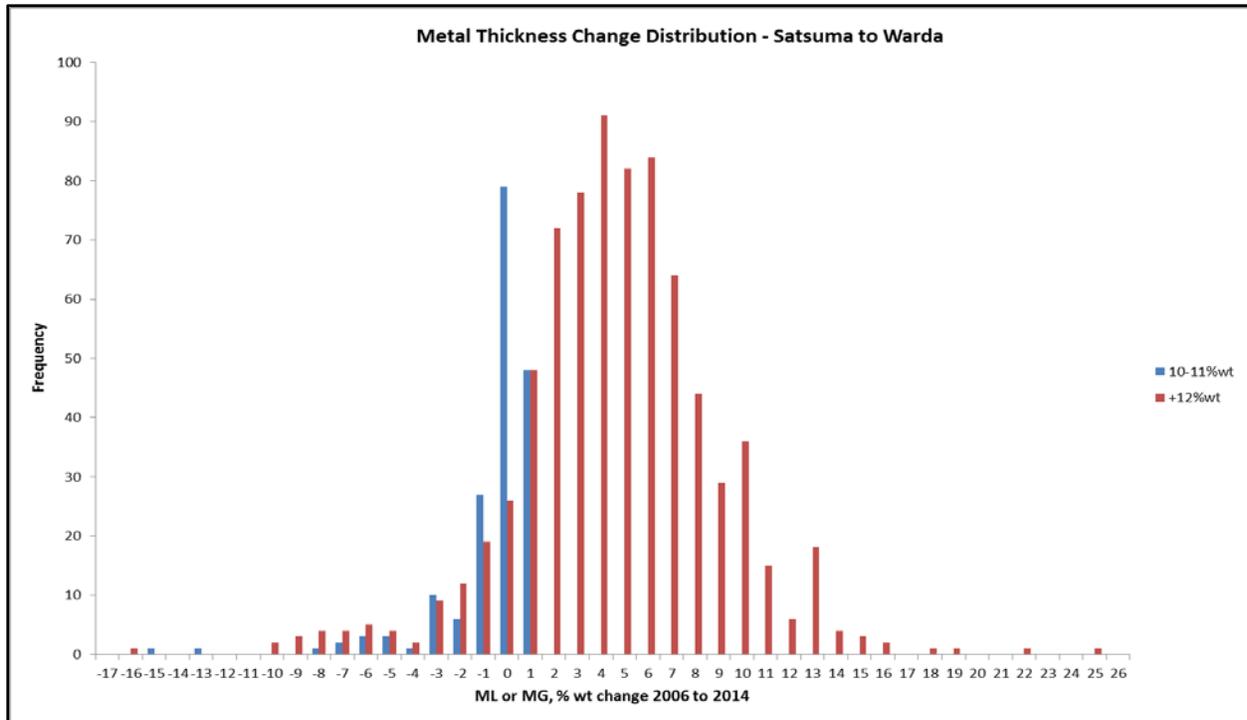
Figure 7. Histogram Showing the Distribution of Metal Loss/Metal Gain Obtained from the 2006 to 2015 MFL Assessment Comparison (3710 Data Points)

The population distribution of the metal loss (ML) or metal gain (MG) used to calculate CGRs were evaluated as the population frequency histogram shown in Figure 7 for the MFL assessments. Assuming a normal distribution for the ML versus MG population the bias in the distribution mean represents either the average CGR for the entire ILI run or it may indicate an ILI error. Figure 7 shows the goodness of fit for a normal distribution for features from the 2015 MFL ILI assessments with a depth greater than 12% WT. Metal loss features with depths of 10 and 11% WT from the 2015 MFL ILI assessments were not included in the CGR analysis due to the uncertainty of the accuracy of the 2006/2007 MFL assessment depths for these features.

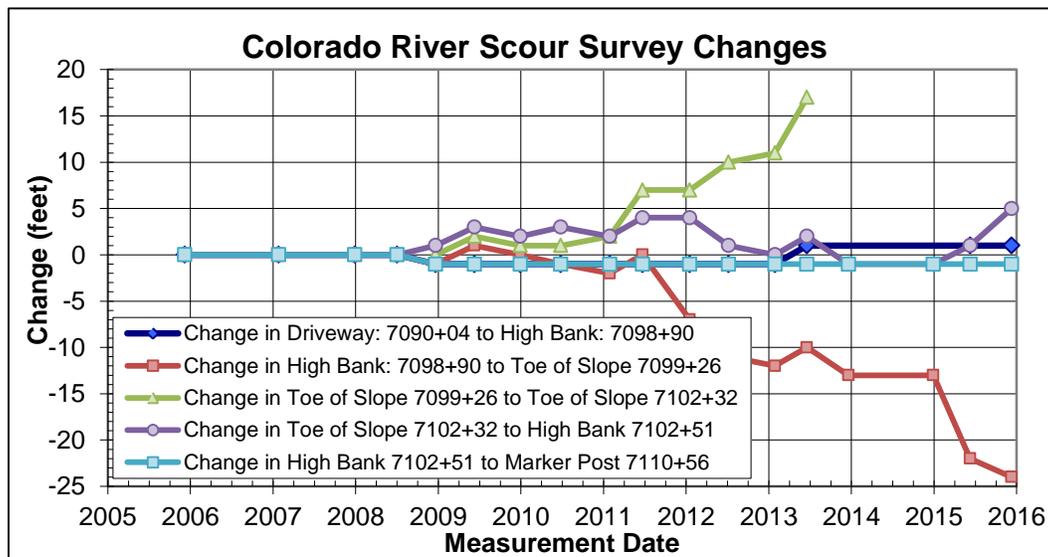
Figure 11. Changes in the Scour Survey of the Colorado River over 8 Years

As shown in Figure 11 for the Colorado River Crossing, no movement of bank locations was detected at the water crossing from the constant distance between the driveway at 7090+04 and the East High Bank at 7098+90 and the constant distance between the West High Bank at 7102+51 and the Marker Post at 7110+56. The distance between the East High Bank and the toe of the slope decreased by 11 feet in 2015. The total decrease of the distance compared to that in 2006 reached 24 feet. The distance between the West High Bank and the top of the slope increased by 5 feet in 2015. The distance between the two toes of the slope were not

Magellan is committed to continue conducting two inspections per year at the two crossings and monitoring the depth of cover of the pipeline and scouring of the banks.
