2018 Operational Reliability Assessment of the Longhorn Pipeline System

March 25, 2020

**2018 OPERATIONAL RELIABILITY ASSESSMENT OF THE LONGHORN PIPELINE
SYSTEM**

MAGELLAN PIPELINE COMPANY

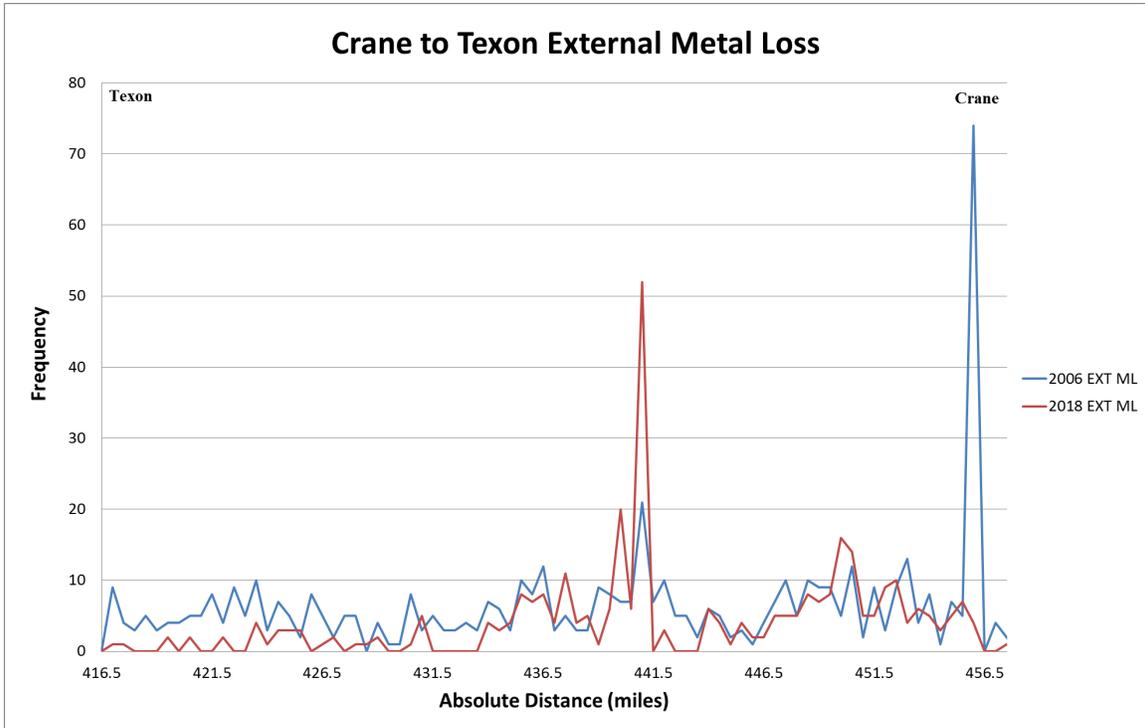
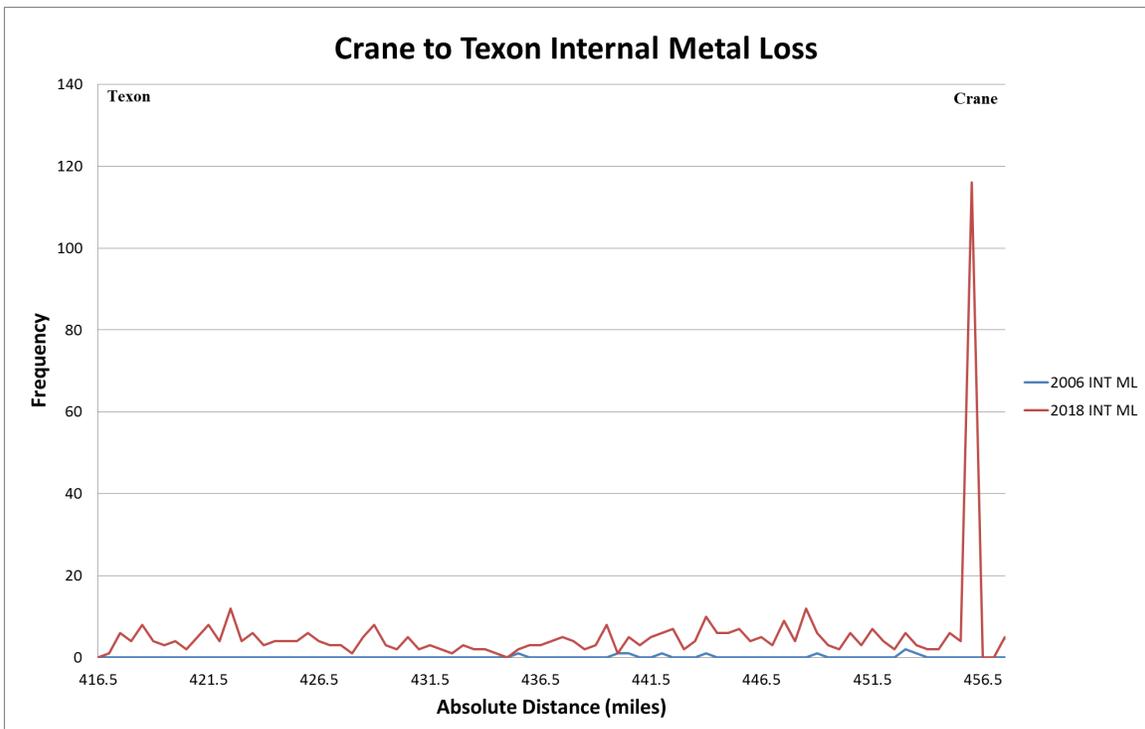
Figure 6. Crane to Texon Metal Loss Frequency by Linear Distance along the Pipeline (2006 MFL vs 2018 MFL)

Figure 8 shows the 2017 ILI assessment as reporting more internal metal loss throughout the assessment as compared with the internal metal loss reported in the 2012 ILI assessment. Figure 6 shows that the external metal loss features are showing a similar trend in reported metal loss along the pipeline. Near MP 456.5 there is an increase in metal loss feature count compared to the rest of the line segment. As shown in Figure 6, the metal loss is reported as external based on the 2006 MFL data while the 2018 MFL data indicates the metal loss as internal; indicating there is an internal/external feature call discrepancy between assessments. Figure 7 shows higher external metal loss feature counts in the 2013 assessment between MP 497.5 and 527.5 compared to the 2018 assessment; the run-to-run comparison indicated some internal/external feature call discrepancy in this area. All three figures (Figure 6 through Figure 8) are showing areas where the 2018 MFL data has reported an increase in metal loss features over the previous assessment. The increase in metal loss features appears to be occurring in the low level feature counts (ML \leq 20% WT).

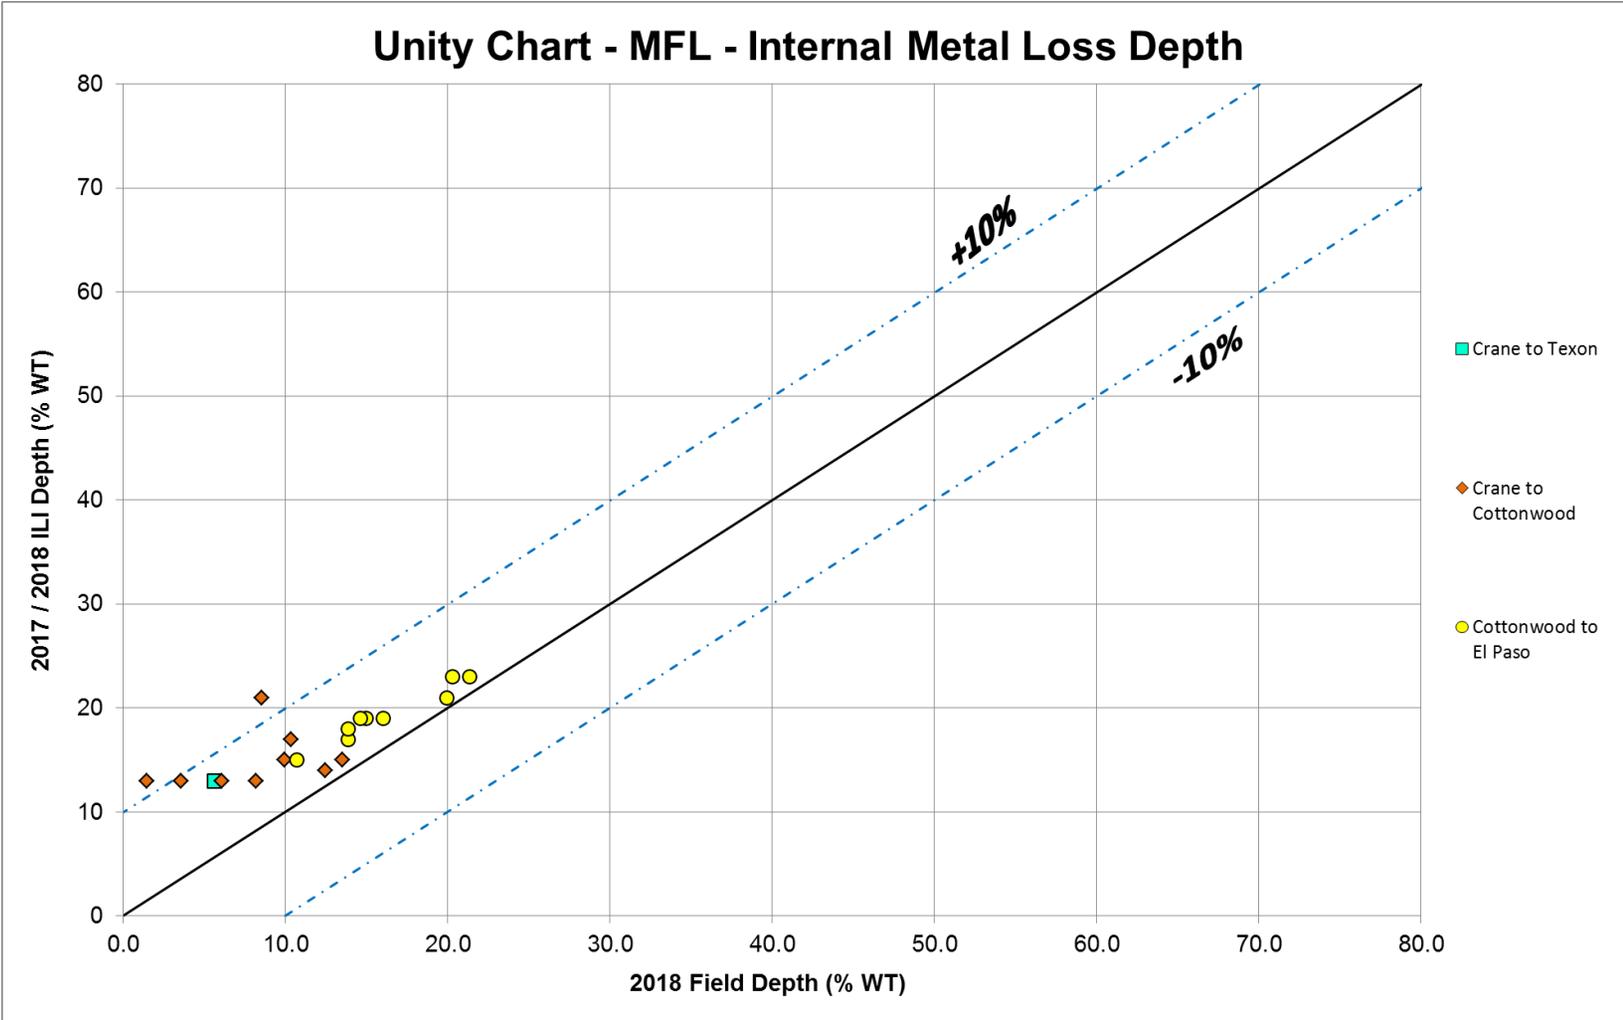
Figure 9. Unity Chart for Depth Verification for MFL Internal Metal Loss (Upper Bound ±10% WT)

The 2017 and 2018 MFL assessments from Crane to Texon, Crane to Cottonwood, and Cottonwood to El Paso were correlated with 2018 dig results found in the in-ditch ILI anomaly investigation maintenance and NDE reports. The ILI anomaly investigation digs resulted in 57 individually correlated features. A breakdown of the ILI anomaly investigation dig data correlations can be found in Table 14. No laminations were identified during 23 ILI investigation digs. The 2018 field investigations resulted in 19 internal ML to internal ML data pairs (1 from Crane to Texon and 18 from Crane to El Paso). All 19 ML data pairs correlate to the 2017/2018 MFL assessments. A review of the MFL internal ML to internal ML data pairs found 17 out of the 19 correlations were within the $\pm 10\%$ tool performance specification. Figure 9 shows the in-ditch and ILI data pairs expressed as a unity plot for the MFL data; the unity plot is indicating that the MFL tool tended to over call depth on an average of 5.0% for correctly identified internal metal loss features found in 2018 for the Crane to Cottonwood and Cottonwood to El Paso segments. There is not enough data to determine a trend for the MFL tool on the Crane to Texon segment.

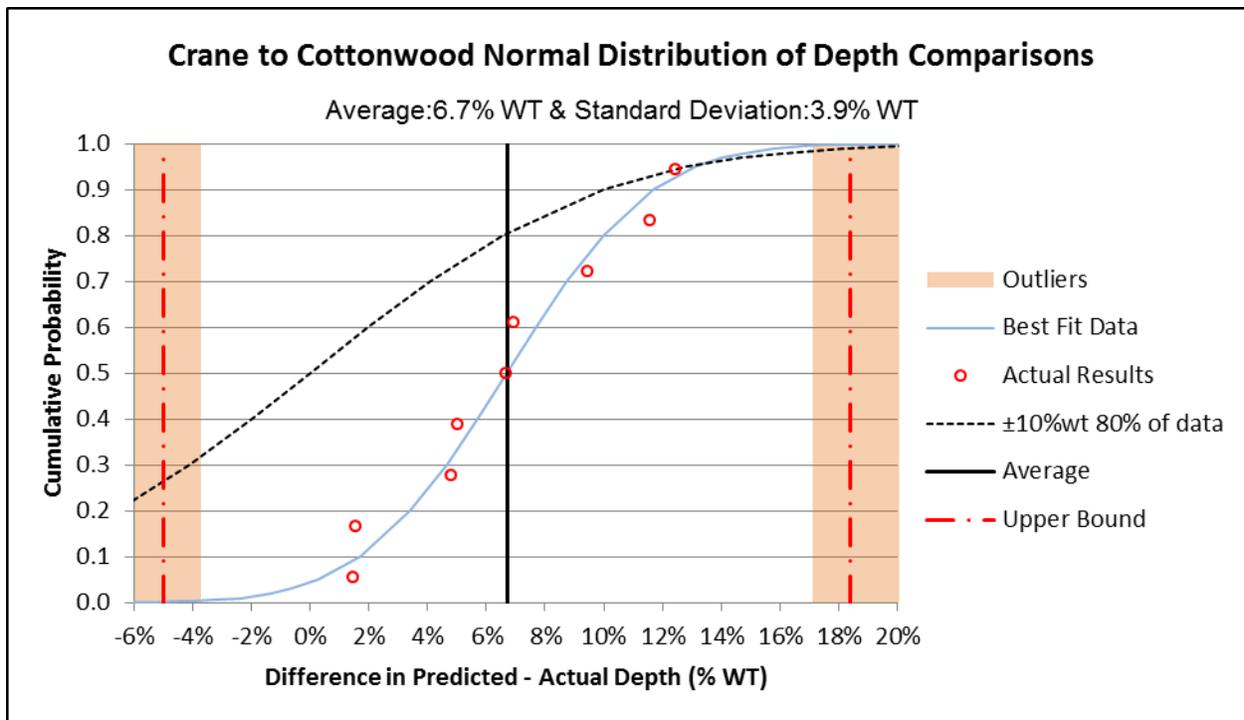
Figure 10. Internal Metal Loss Normal Distribution Chart for the Difference between In-ditch and ILI Predicted Depths for 2018 Crane to Cottonwood ILI Anomaly Investigation Data Pairs

A statistical analysis was performed to determine the average, standard deviation and if outliers or extreme values were present. Additional information on average, standard deviation, outliers, and extreme value can be found in Appendix D – Introduction to Normal Distribution and Outliers. The statistical analysis results are shown in Table 15; a negative value represents that the ILI tool has under called the features when compared to the in-ditch data. No correlated features were removed from the statistical analysis. Table 15 and Figure 10 and Figure 11 demonstrate the difference between the ILI predicted depth and in-ditch depth based on a normal distribution for all correlated internal metal loss features used in the statistical analysis. Comparing the best fit curves to the correlated data shows that there are areas of deviation from the curve. This indicates that the correlated data could be non-normally distributed. Additional features would be needed to conclusively support a bias.
